T-90 Rebuild Guide

Rick Stivers

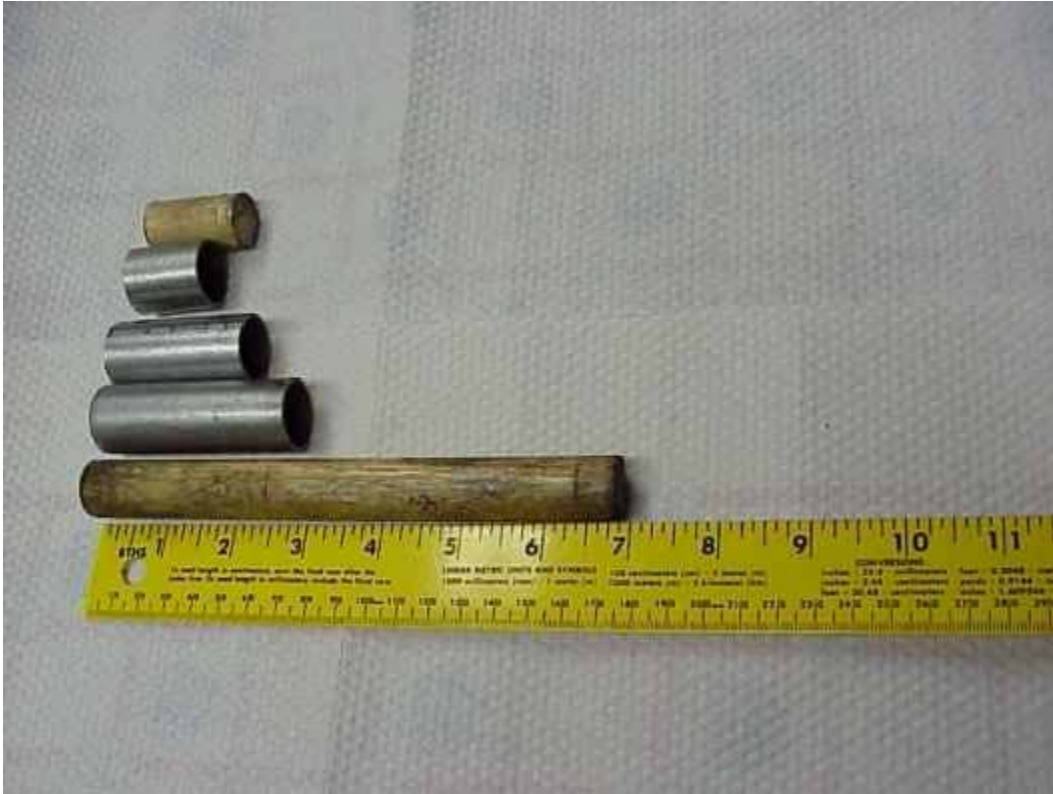
1a. Tool A is manufactured using a 3/4" wooden dowel rod. Cut it to 6 7/8" long. If the dowel rod has a rough finish, it should be sanded smooth and the ends lightly rounded. I did this using a 2" long drywall screw mounted in my drill. I turned on the drill and screwed the screw into the end of the rod, as soon as it snugged up, the rod was spinning nicely. It made sanding very easy.

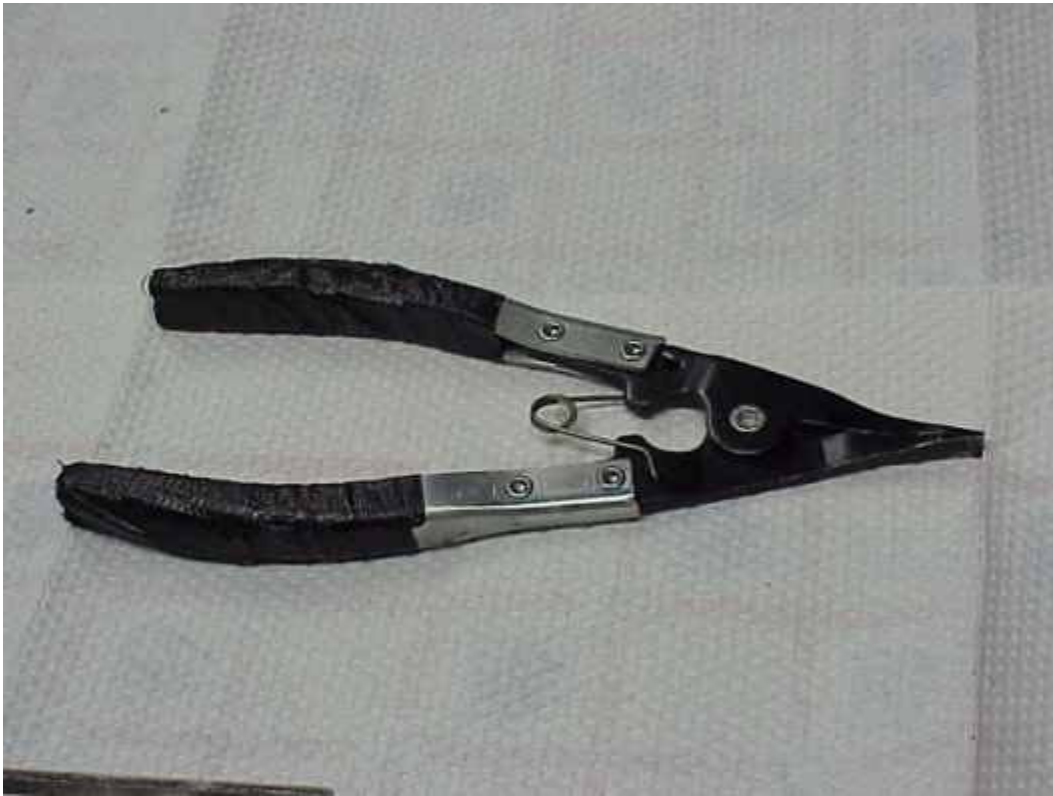
Pair of flat bladed snap ring pliers.

Round tipped pliers will not work.

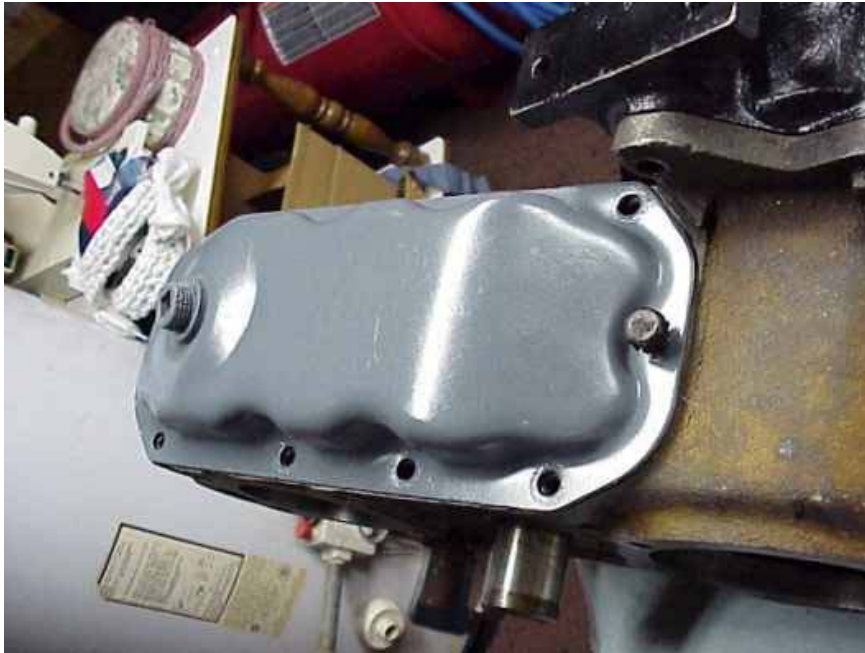
2b. Remove transfer case bottom cover.

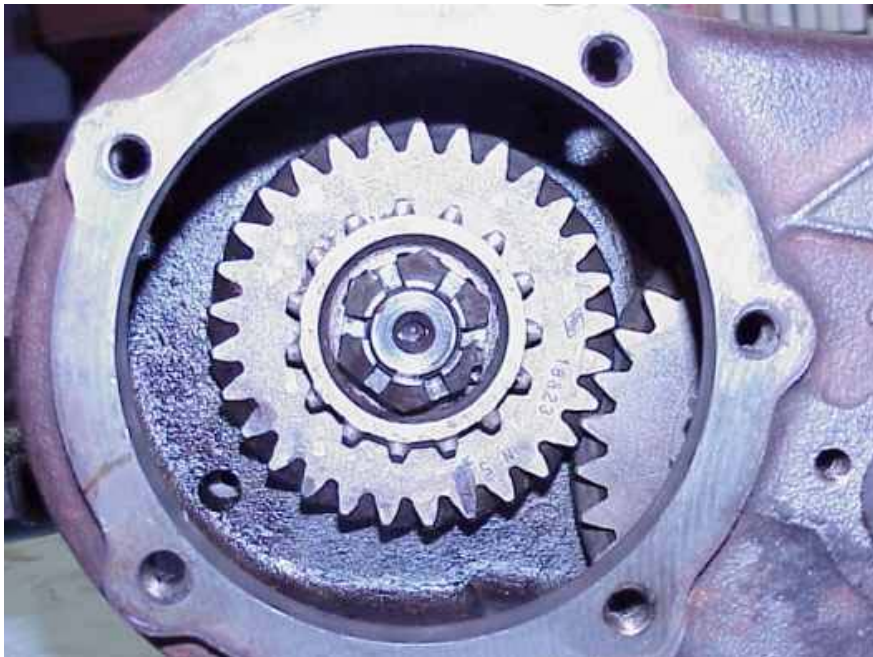
2c. Remove the cotter pin, nut and washer.

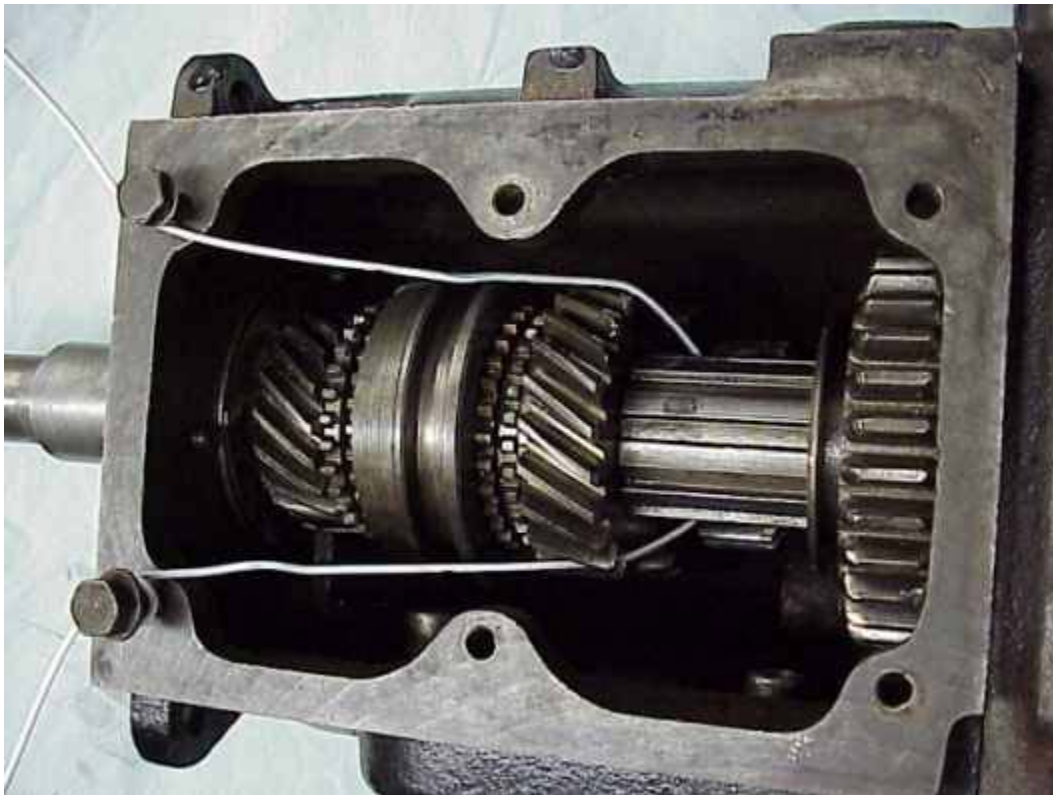
2e. To hold the mainshaft in place until removal is desired, install the front two shift tower screws back into their holes. Loop a heavy piece of wire under and behind the second speed gear and tightly wrap it around each of the two screws.

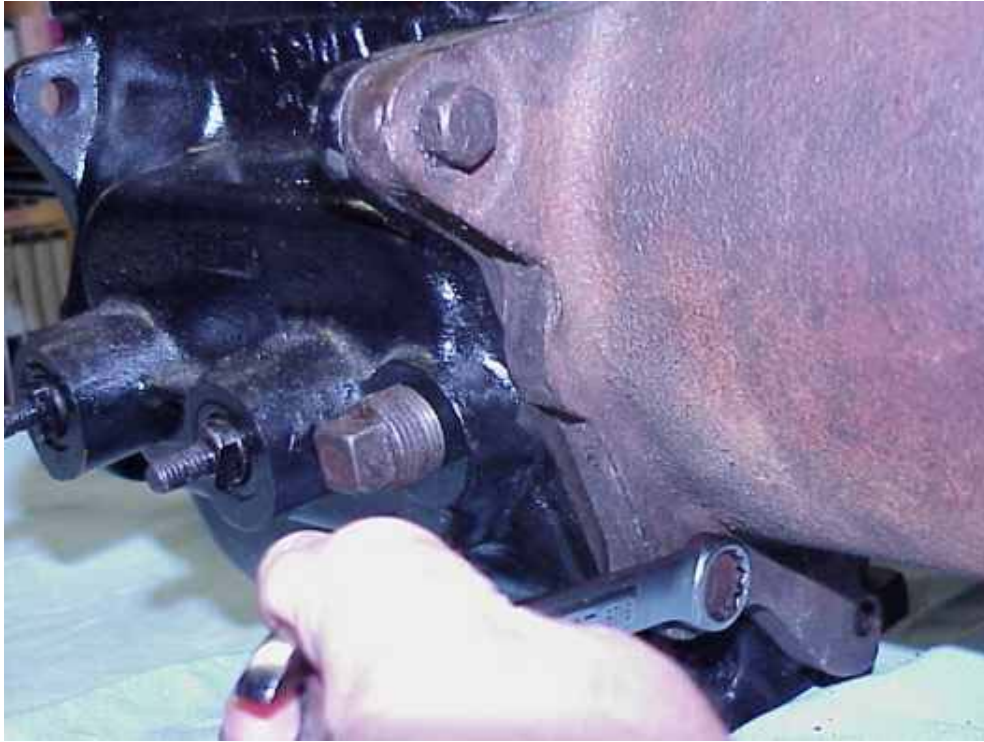
2f. Remove the transmission to transfer case bolts.

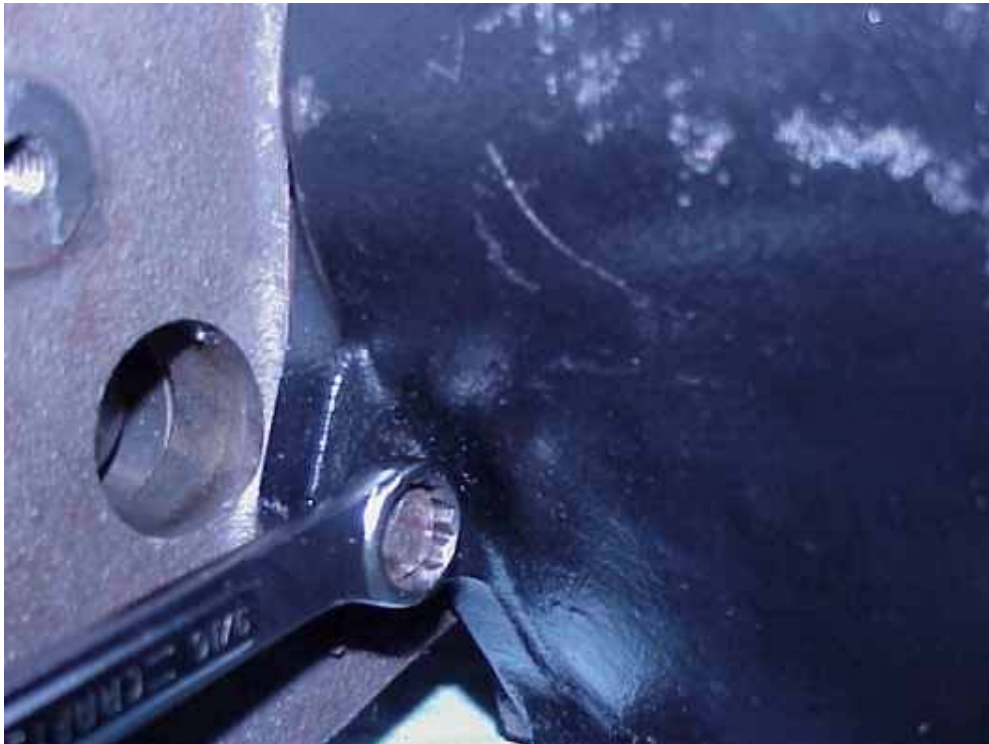
There is one bolt that is somewhat hidden on the opposite side from the first bolts. It is on the front side of the transfer-case. Make sure to remove this bolt

or you could crack the T-90 case trying to force them apart.

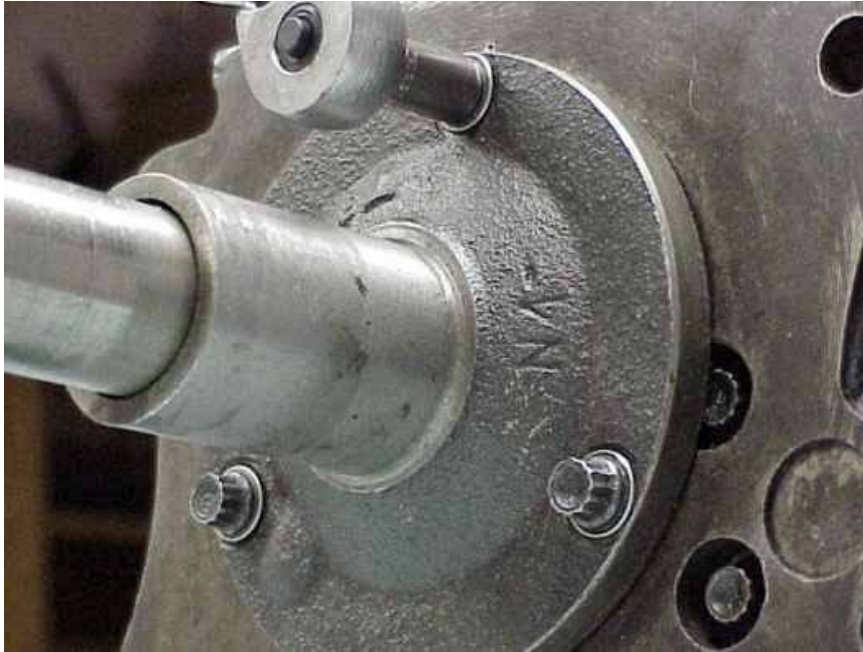
2h. Remove the three screws from the main drive gear bearing retainer.

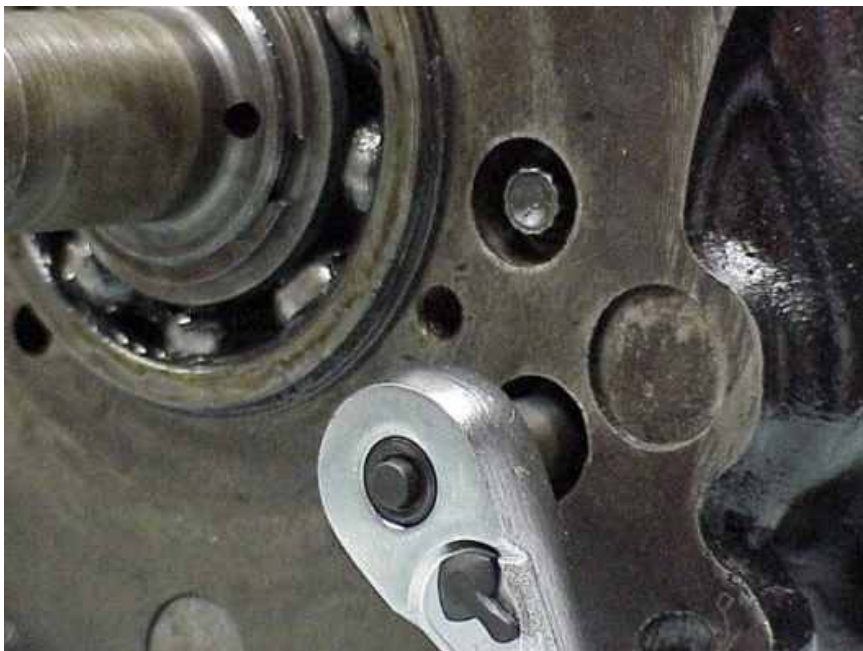
2j. Remove the two twelve point/socket head screws that hold the oil collector to the case.

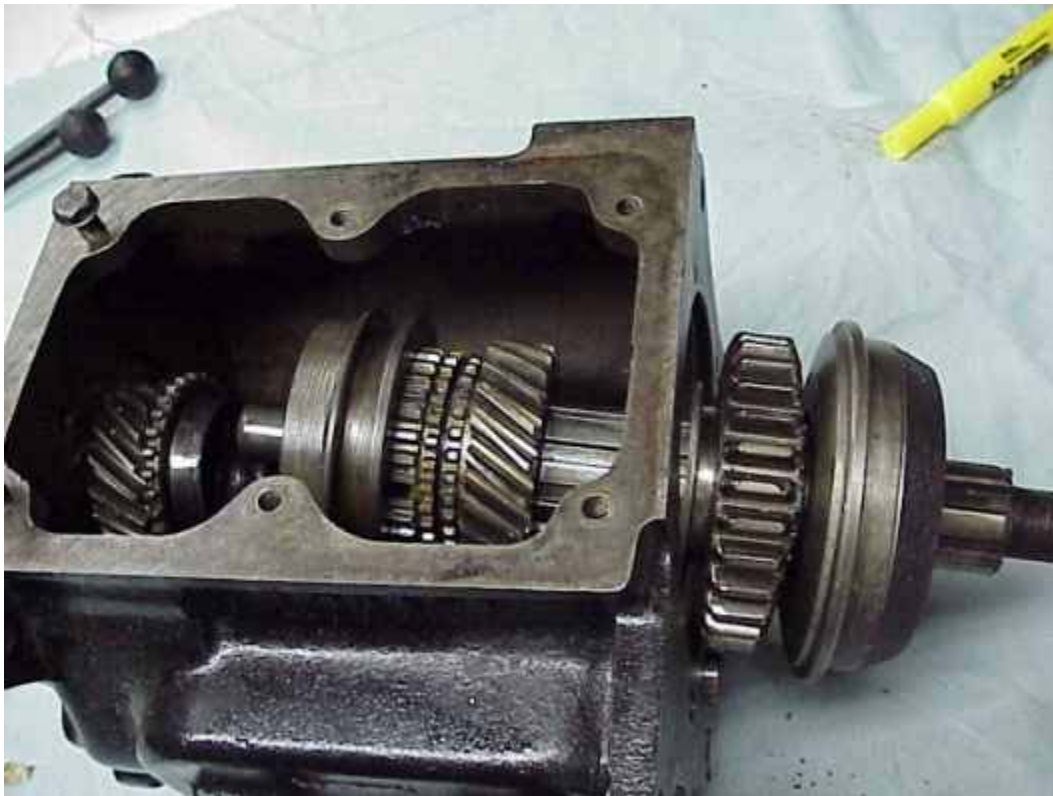
2n. Slide the mainshaft complete with the front synchronizer blocking ring backwards, then tilt the front end upward to clear the cluster gear

and slide it out of the case through the rear opening.

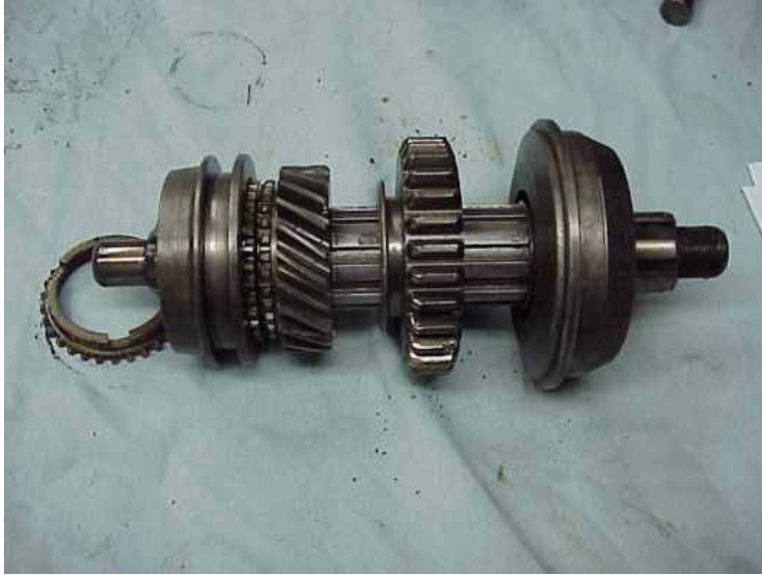
(Some T-90s have the counter shaft locking plate installed over the top of the rear-bearing adapter. This will prevent the rear-bearing adapter from being removed. If this is the case on your T-90 you will need to remove the locking plate as described in step 2o - 2q prior to removing the mainshaft. This may prove to be difficult due to the limited space for accessing the reverse idler gear shaft with the mainshaft installed. In this case brute force applied to the locking plate may be required.)

Merl - Disassembly was easy, the hardest part was getting that locking plate out of the slots on the rear of the two shafts. As Rick mentioned, mine was inserted from the top down and I couldn't get the rear bearing adapter plate off without first removing this plate. I bunged up the plate really well and wound up getting a replacement for it.

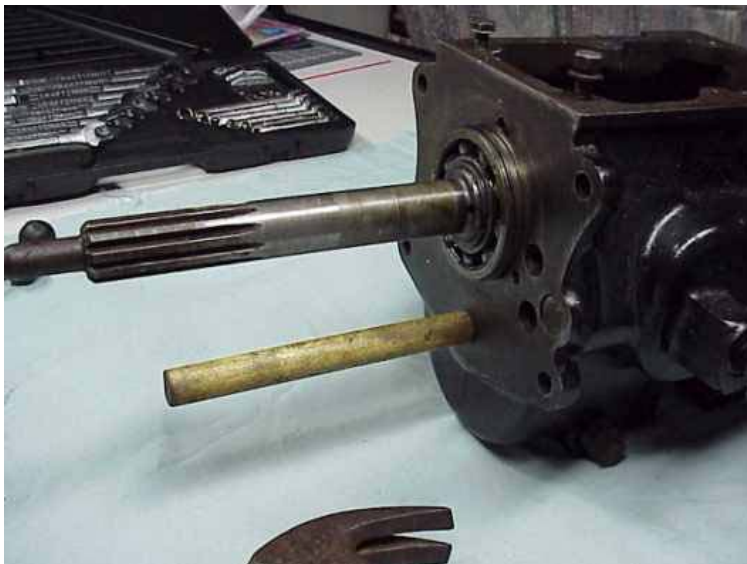
2o. Using Tool A or a brass drift, gently tap the countershaft toward the rear of the transmission about 1/2".

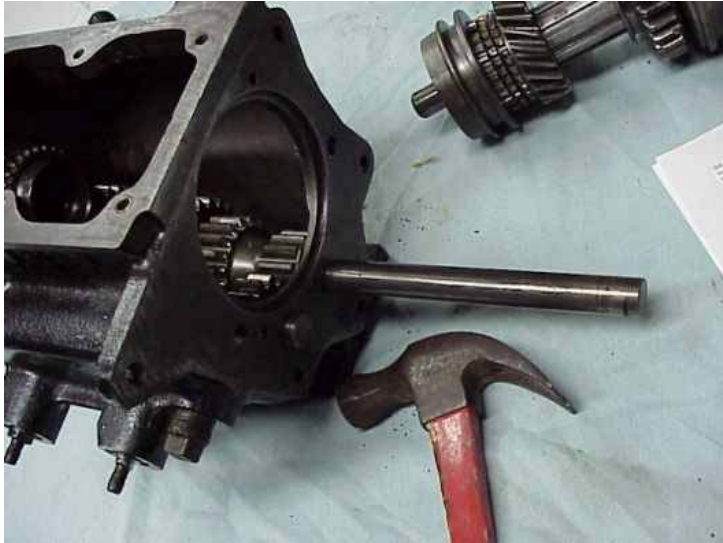
2r. Using tool A drive the countershaft out of the cluster gear.

Rick Grover - When you say to drive the counter shaft out, it should be driven out to the rear. The front hole is a few thousandths smaller than the back hole. Driving it out the front would be much harder and could stretch the front hole.

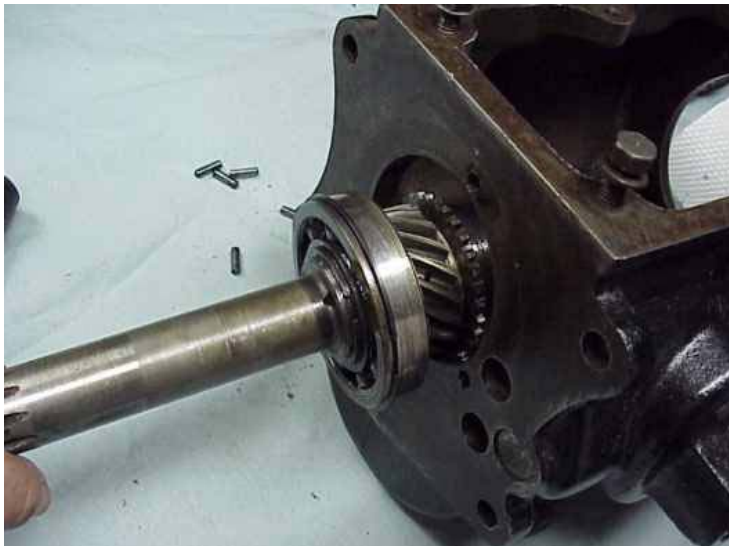
2t. Tap the main drive gear forward and out of the case.

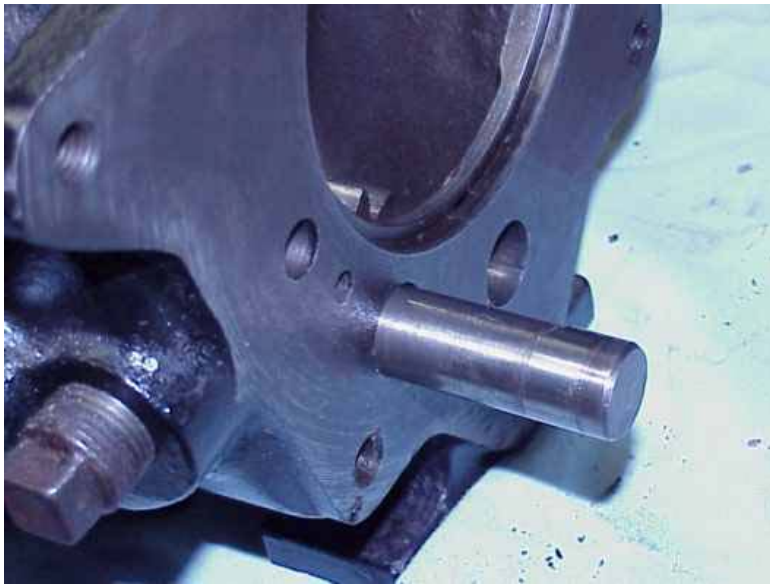
2y, Using tool E drive the reverse idler gear shaft out the back of the case.

(This must be done from inside the case. Caution: do not attempt to drive the shaft into the case from the rear as this can damage the shaft and the case. Remove the reverse idler gear from the case. Some people have found it necessary to use a bent piece of rebar to drive the reverse idler gear out of the case. Use as little force as you can to prevent damage. Whatever you do, don't drive the shaft into the case.)

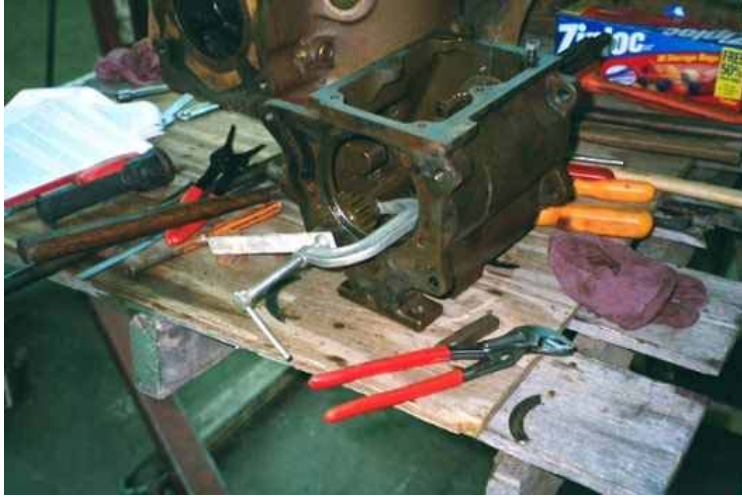
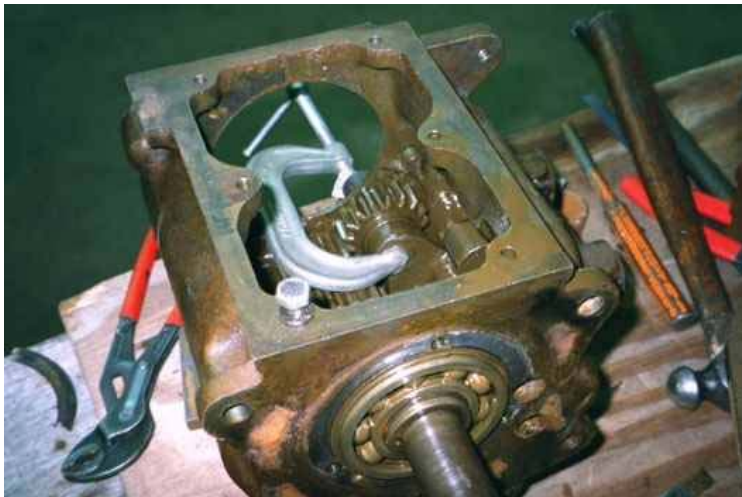
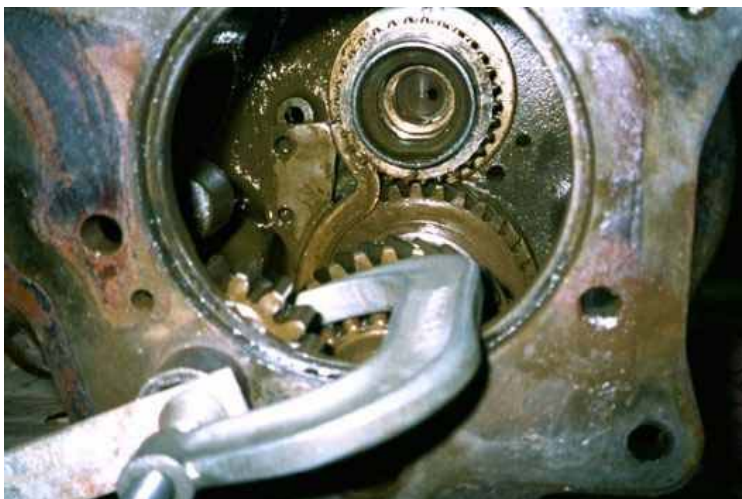
(Danny M. has provided us with an alternative method of removing the reverse idler shaft. Use a 4 inch C-Clamp, a 3/8" drive 1/2" socket and a 3/8" drive 3/4" deep-well socket. Install the C-Clamp as shown

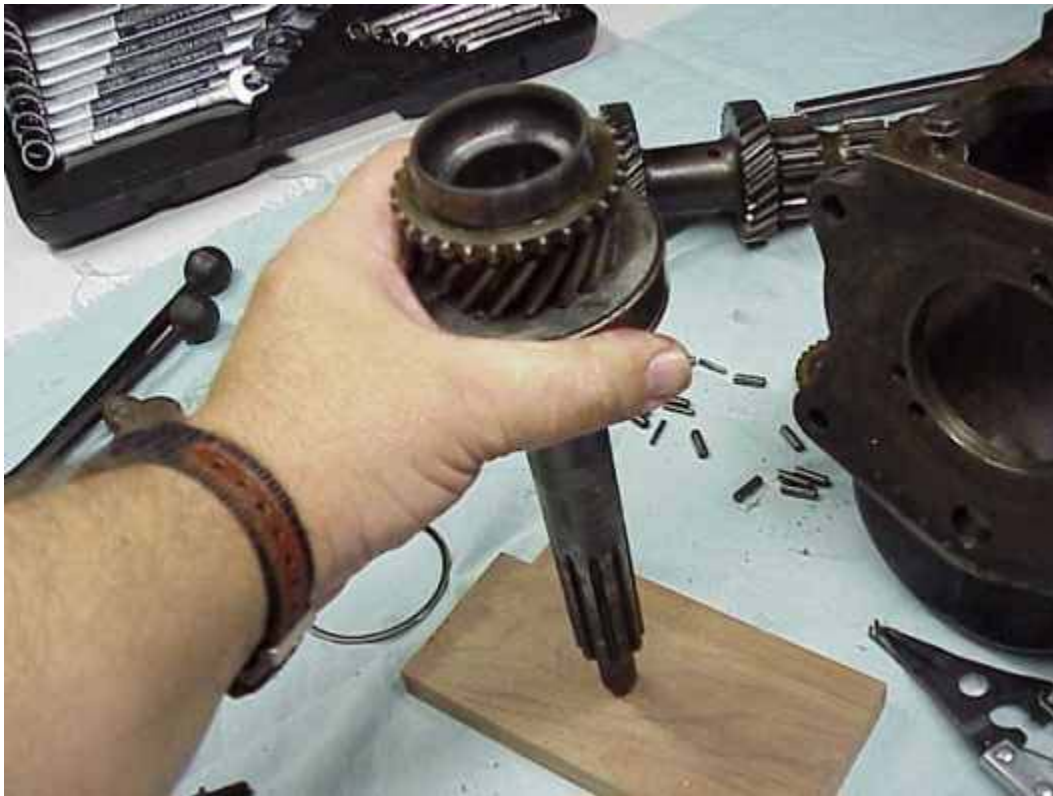
2aa. Hold the main drive gear by the bearing and gently tap the small end of the shaft onto a board

until the bearing slides down and off the gear shaft.

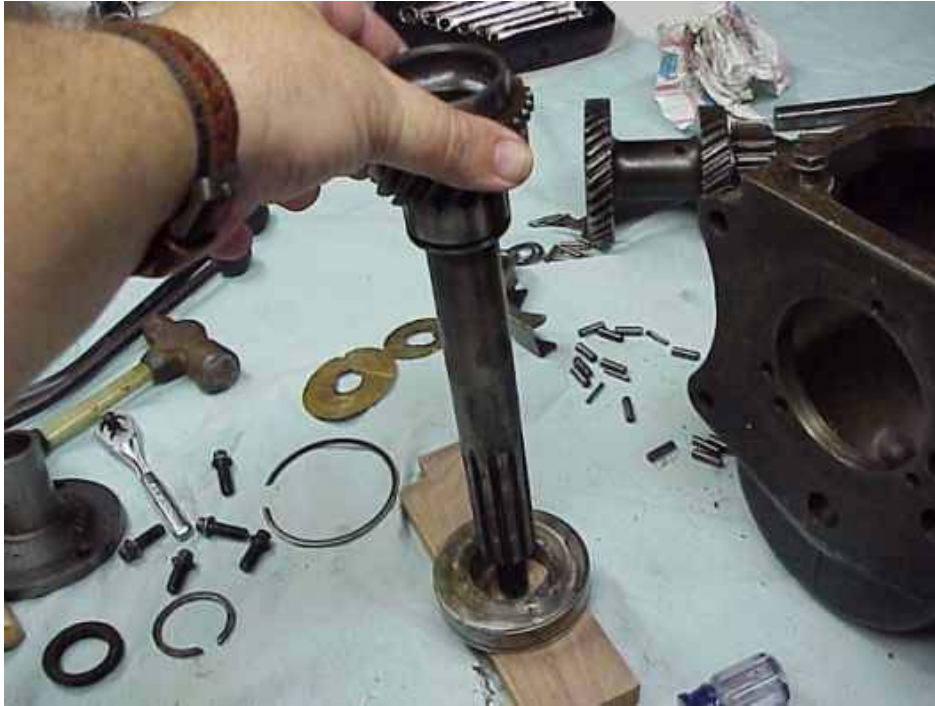
Rick Grover - An alternative is several taps with the brass hammer. Worked for me. :-)

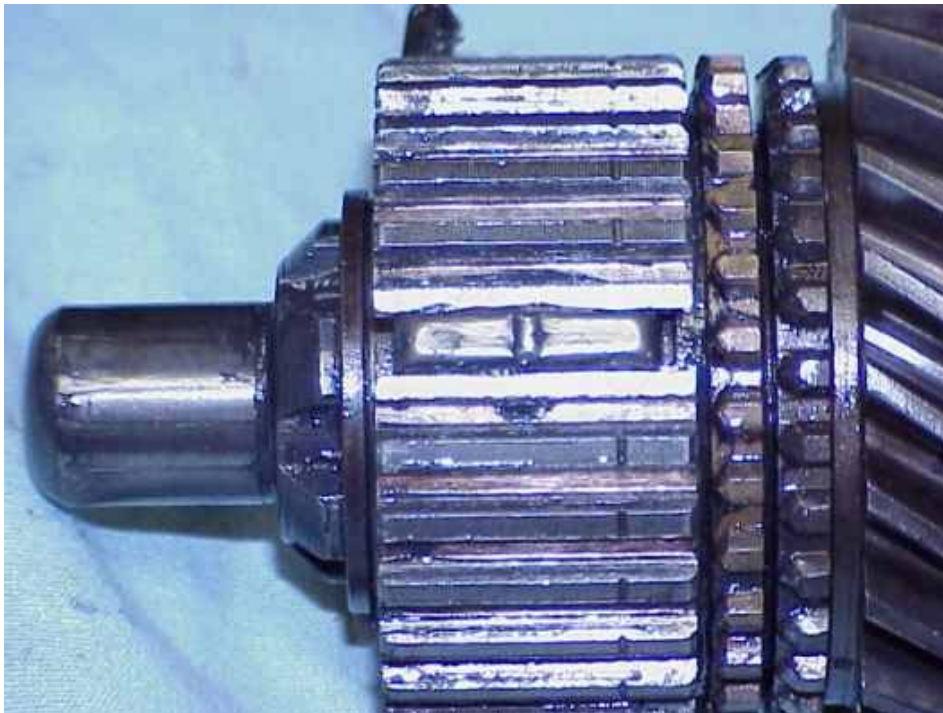
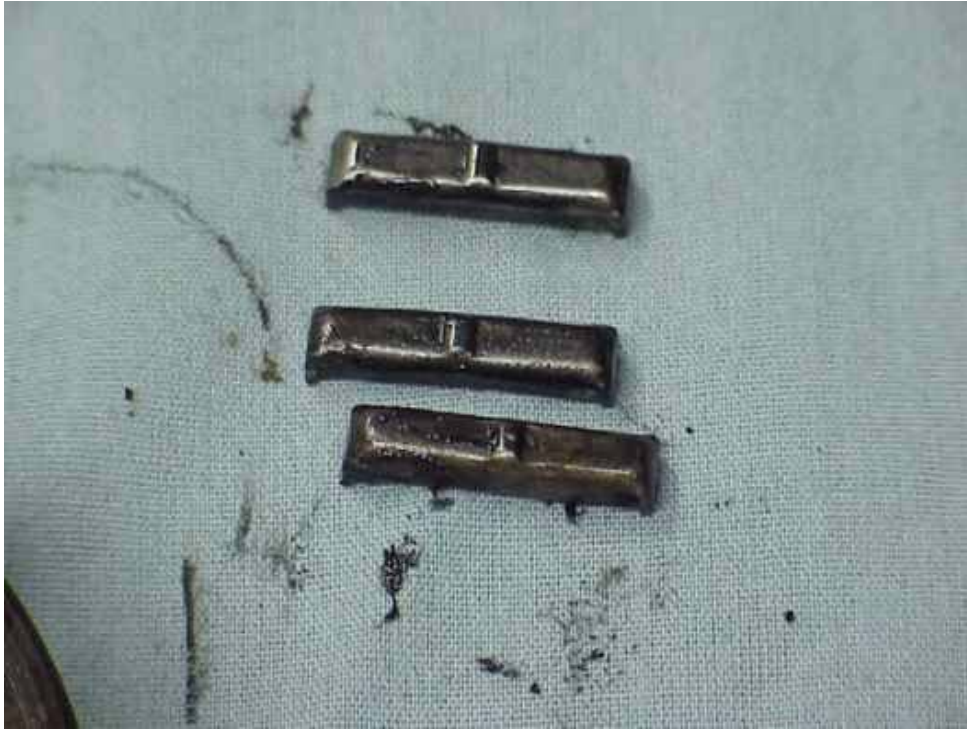
2cc. Slide the clutch sleeve off of the clutch hub, making sure not to drop the

three synchronizer plates.

(Collect the synchronizer plates and put them off to one side for inspection.)

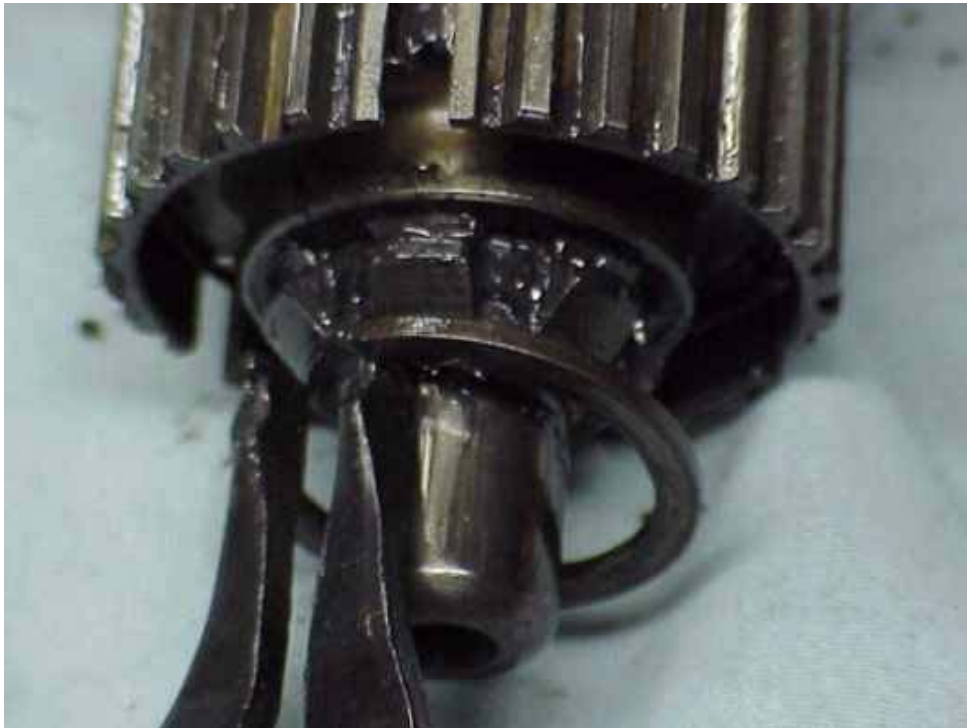
2dd. Using flat edged snap ring pliers remove the clutch hub snap ring.

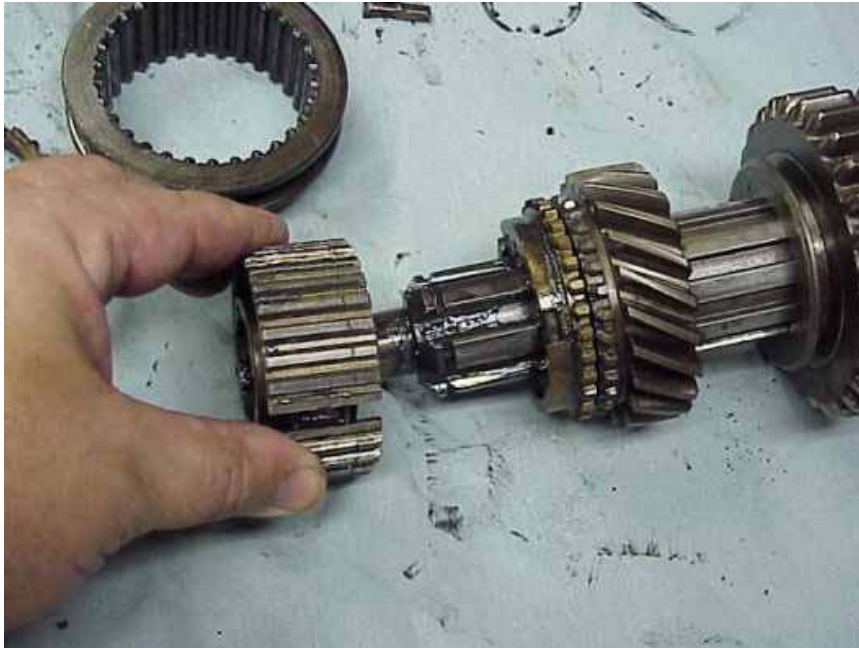
2ee. Remove the clutch hub from the mainshaft.

(You may find that the clutch hub will not want to slide off the main shaft after you have removed the snap ring. Holding onto the clutch hub while gently tapping the mainshaft with a brass hammer will usually coax it off. Warning - years of the clutch sleeve sliding on the clutch hub can cause very sharp edges to develop. Use caution when handling the sleeve and hub.)

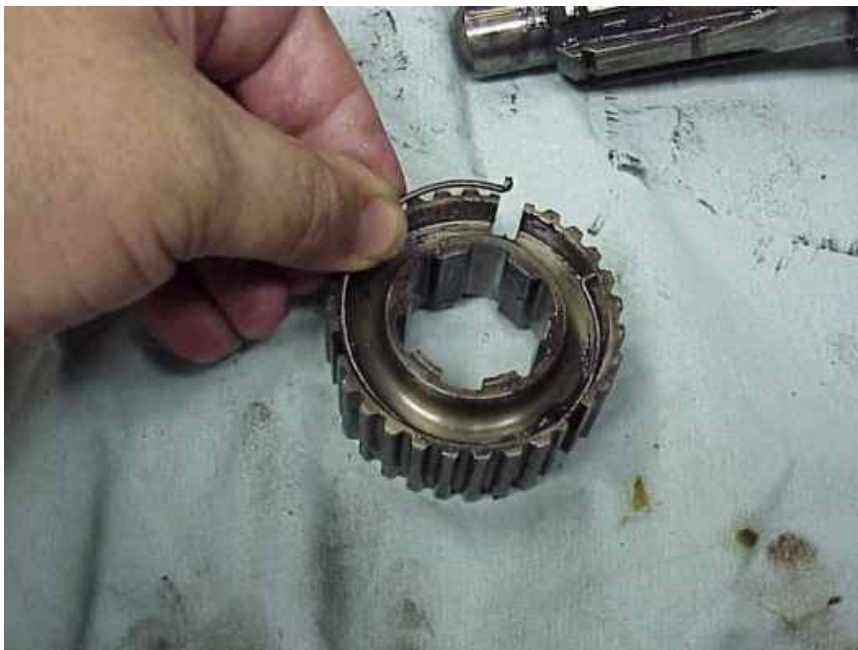
2ff. Remove the synchronizer springs from the hub.

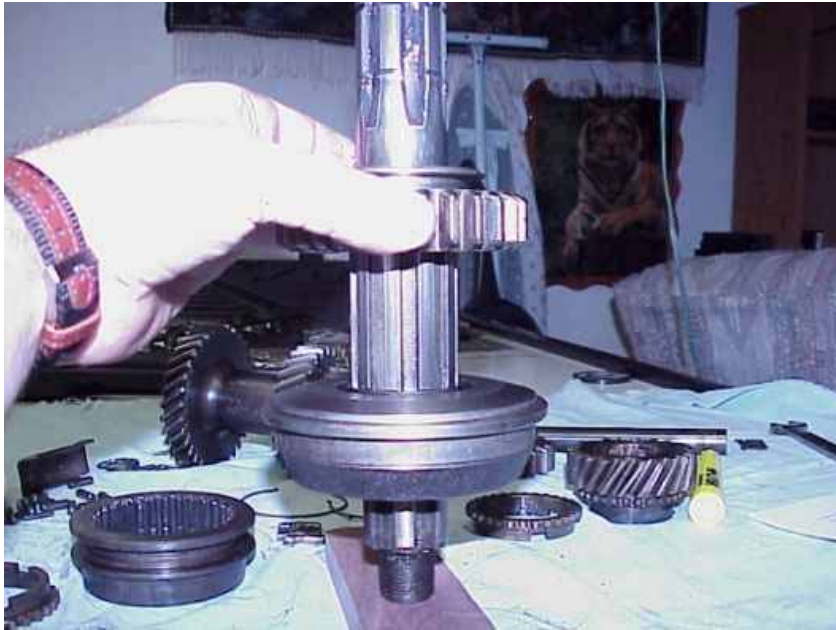
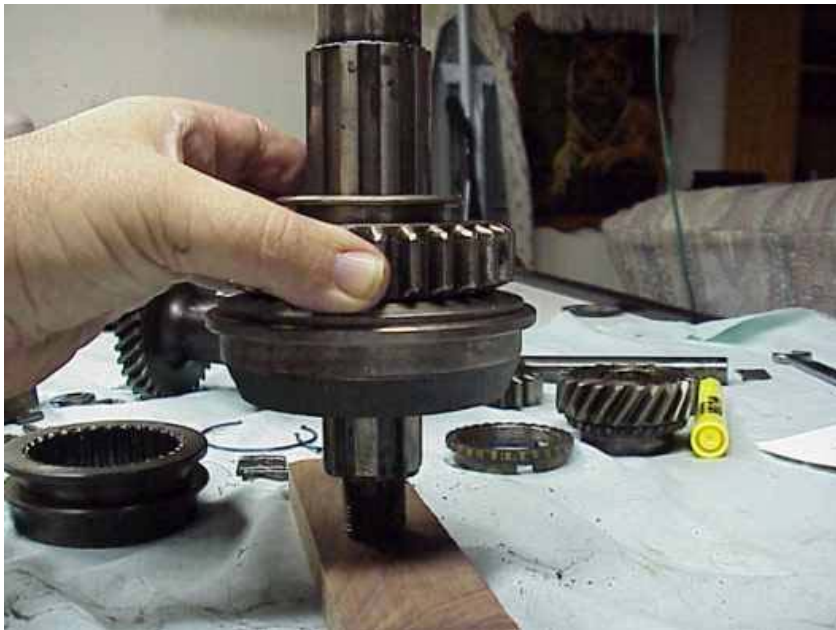
2jj. Remove the rear bearing from the mainshaft. If necessary, stand mainshaft on its tail end and use the 1st/Reverse gear like a slide hammer to drive the rear bearing off the shaft.

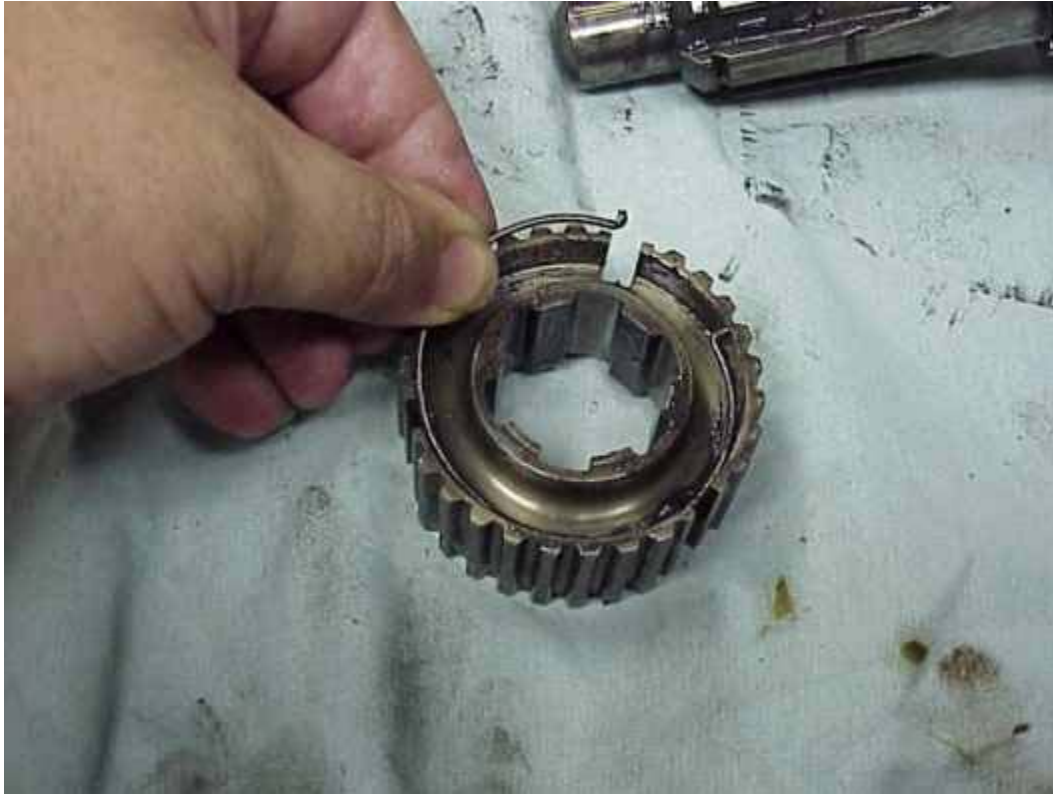
2kk. If you have the large hole bearing adapter, remove the snap ring from inside the bearing adapter.

(You can not use snap ring pliers to remove this snap ring. A flat bladed screwdriver works just fine. Hook it under the notch in the ring and pry the ring out. Place the bearing on the front end of the mainshaft again use a slide hammer action to drive the bearing from the adapter.

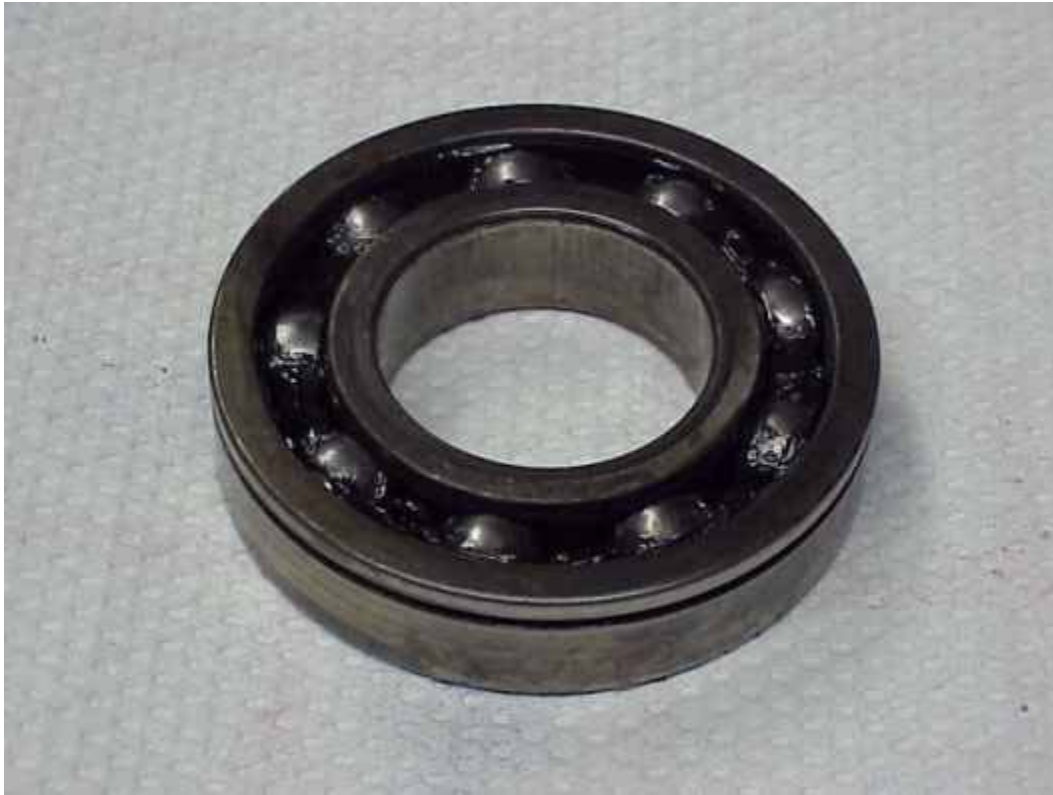
1. The main Drive Gear bearing

should be replaced if the center wobbles in the cage, grinds when spun or makes a squealing noise. I recommend changing it anyway. This bearing may be changed with a sealed bearing but some things need to be changed if you do this. Whatever bearing you choose, make sure that it has the groove as shown in the picture. This is where the front bearing snap ring sits and it is used to hold the bearing in place.

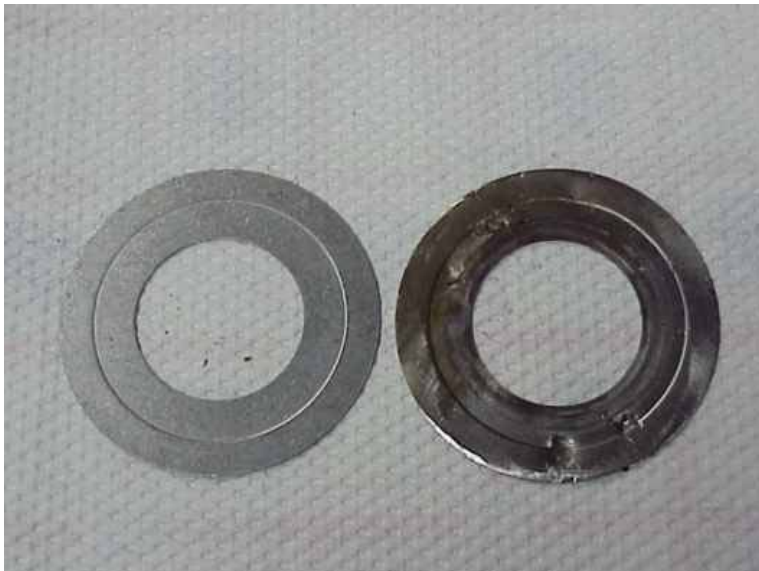
2. The front Bearing Washer should be replaced if bent or scored.

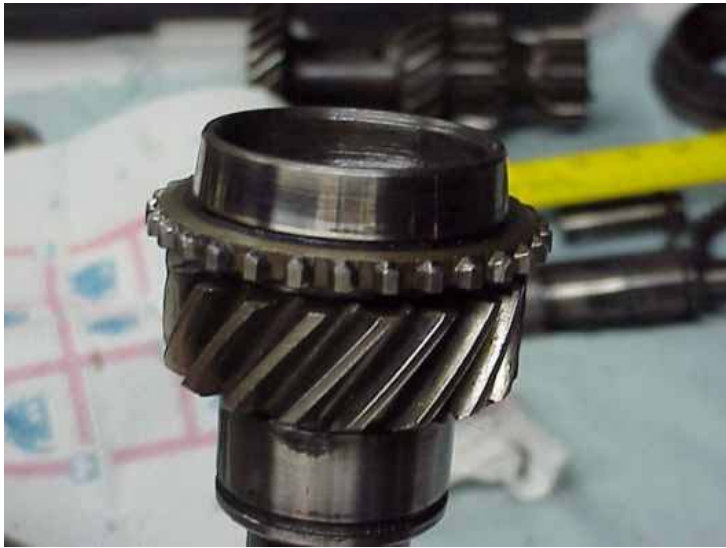
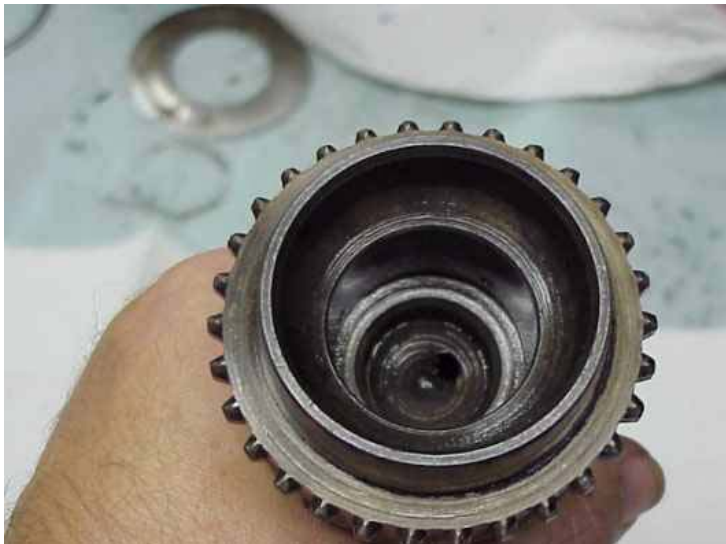
3. On the Main Drive Gear (Referred to by some as the Input Shaft) inspect the pilot-bearing race for scoring and pitting. Inspect all oil passages to insure they are clear. The inside diameter can be checked by measuring the diameter of the pilot shaft on the Mainshaft adding this size to the twice the diameter of a new pilot needle bearing. The sum of these diameters should be within .001" of the inside diameter of the Main Drive Gear pilot bearing race. An easier way to check this is to install new bearings in the race and insert the mainshaft into the bearing. There should be virtually no wobble of the shafts. If this fit is loose it will cause the pilot bushing in the engine crankshaft to wear out quickly. Check the gear teeth and blocking ring teeth for signs of wear and breakage. The beveled surface the blocking ring rides on should be smooth and free of cracks or pits.

If any of these items is damaged you should replace the Main Drive Gear.

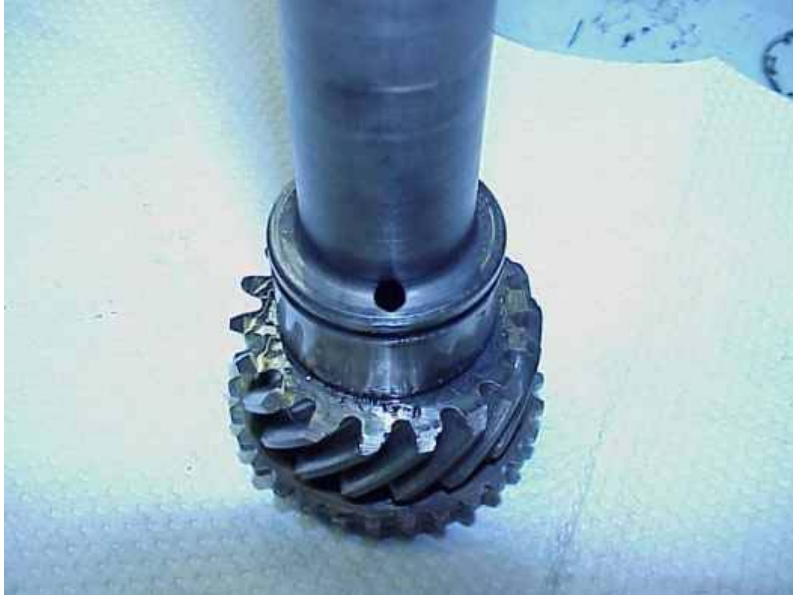
Long Shaft and Short Shaft Main Drive Gears have been identified as being different in more ways than just length. The long shaft has an oil hole drilled from the inside of the pilot-bearing race to the other side of the front main bearing race. It is the dark spot in the bottom as shown in the picture. It is easier to see in this photo taken from the other side. If you install a sealed bearing during installation, you must seal this hole or the transmission will leak.

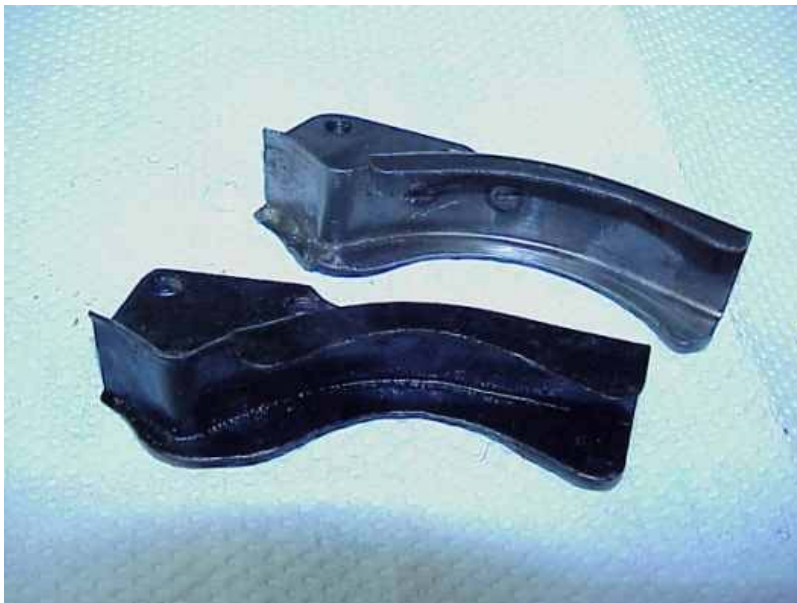
4. Countershaft gear Oil Collector should be examined for cracks and dents. If damaged replace it. Many people recommend leaving this assembly out of the transmission, but I recommend against this. The Oil Collector retains oil around the front end of the Countershaft Cluster Gear. This feeds oil into the needle bearings. In the event that you ran low on oil the collector would continue to feed oil onto the bearings. The Oil Collector will also help to prevent the oil from foaming at high speeds. Note the difference between the old oil collector and the new one.

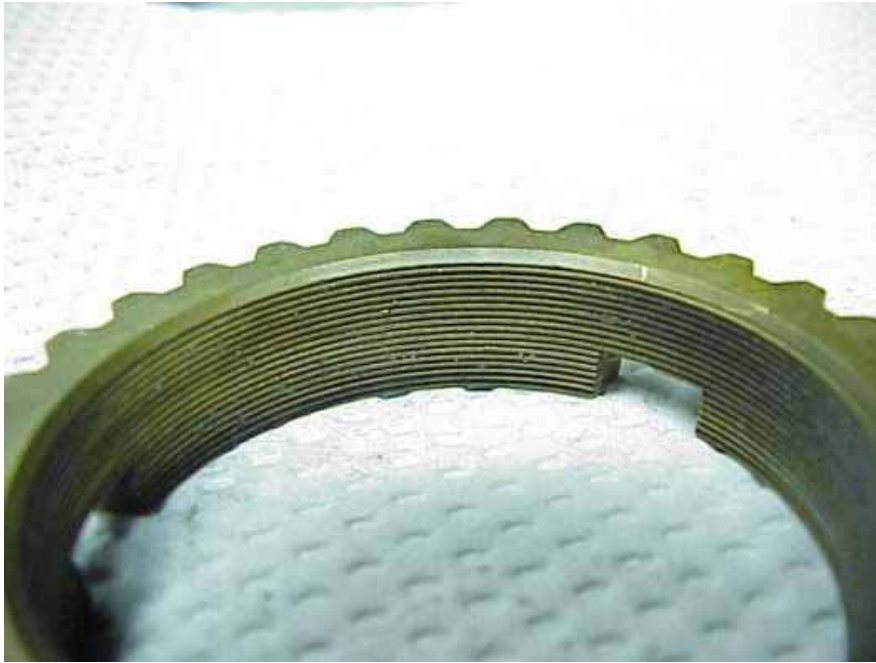
5. The synchronizer blocking rings should be inspected for broken teeth and worn mating surfaces. The mating surfaces that fit against the Main Drive Gear and Second Speed Gear should have small grooves machined into them with raised surfaces that come to points between the grooves and should be free of cracks and chips.
