T-90 Rebuild Guide

Rick Stivers

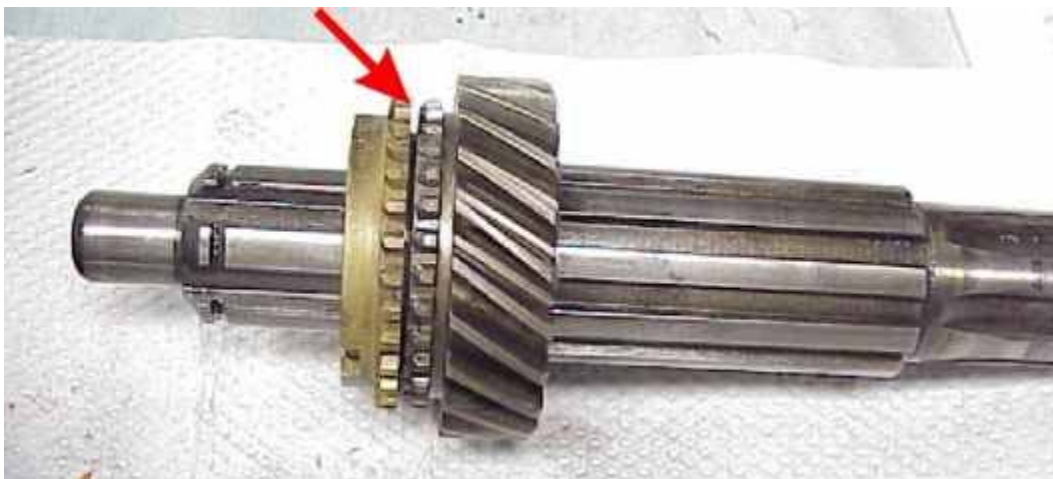
When installed on the Main Drive gear and Second speed gear there should be a gap where the arrow is.

I believe the gap should be at least 0.010" wide. I don't have any documentation to back that up, just my minor experience with these things. The blocking ring should not fit all the way down

over the mating surface. If the rings are damaged or if the grooved surface is contaminated with chunks of metal they should be replaced. I've tried to dig those particles out of there and it isn't worth the effort.

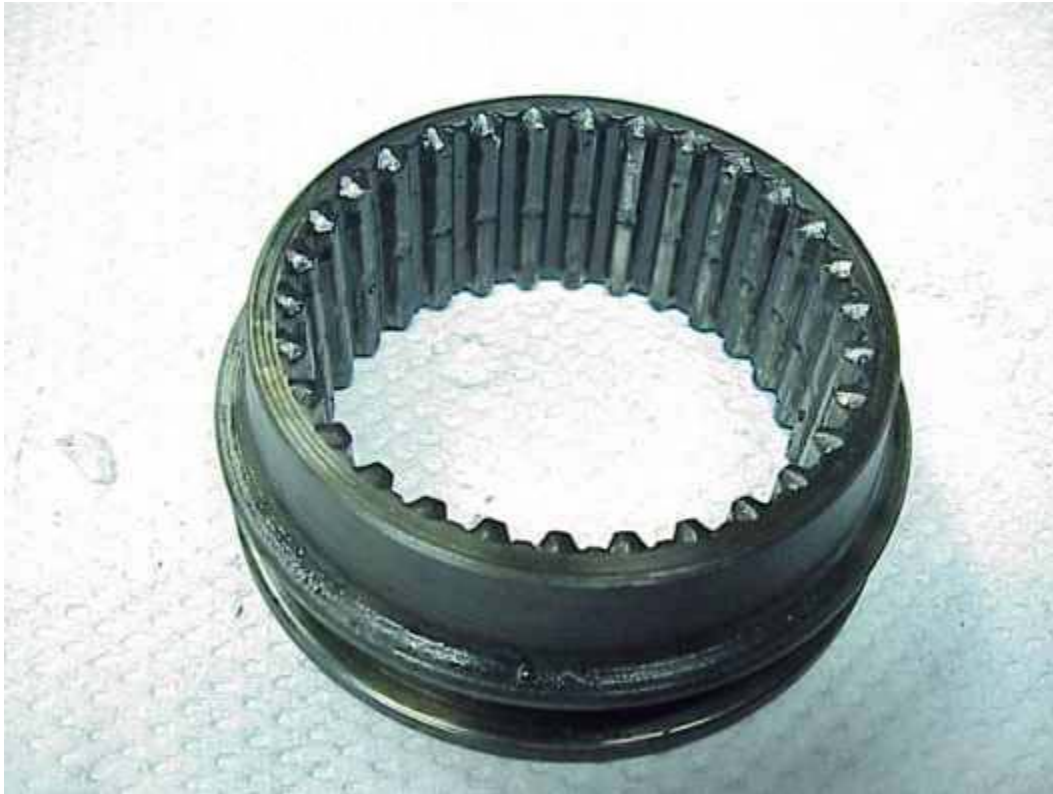
6. The Clutch Sleeve

should be inspected for cracks and pits. Inspect the inside splines for sharp edges and burs. These can be removed with a file or crocus cloth. After cleanup, it should still fit snugly on the clutch hub. If not replace it and the clutch hub.

Rick Grover - The burrs on the inside of the clutch slider were pretty bad on mine. I worried about them and whether or not to replace it, but finally did as you recommended, filed them off with a fine file and emery cloth.

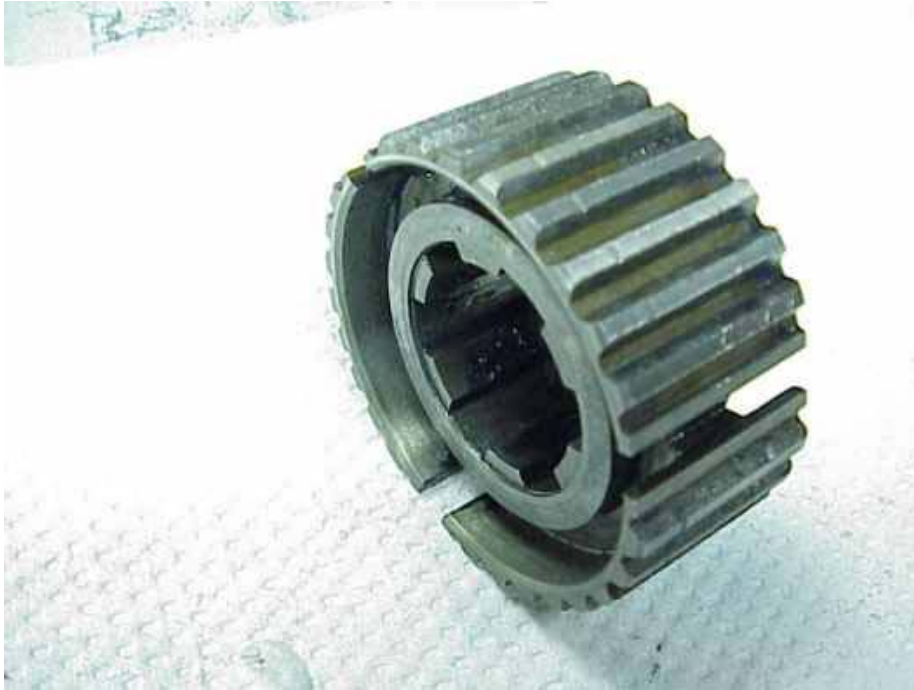
7. The Clutch Hub

should be inspected for sharp edges and burrs on the splines. Caution should be used when handling a used hub as it could have very sharp edges. Using a file or crocus cloth, remove any burrs. Check fit on the Mainshaft and inside the Clutch Sleeve for snug fit. If it does not fit both pieces snugly, replace it.

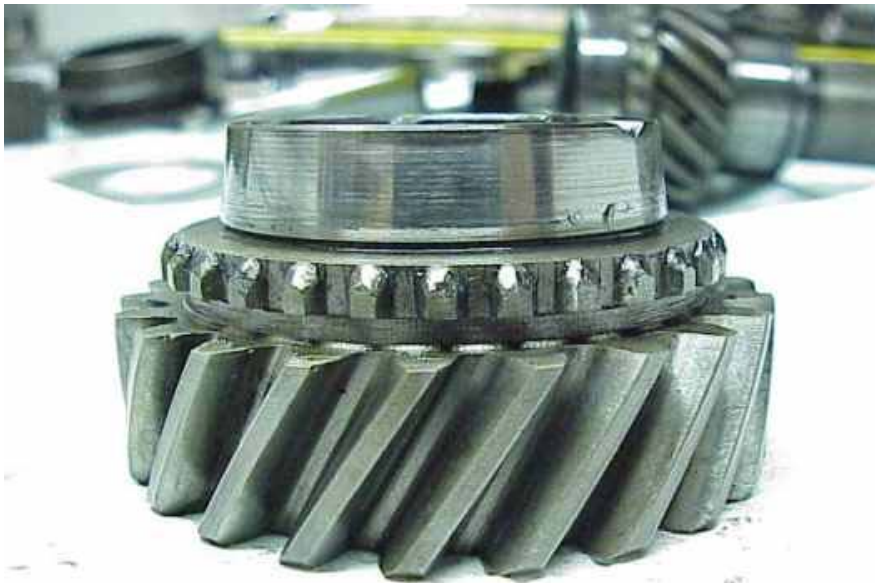
8. The Second Speed Gear

should be inspected for broken or worn teeth. Examine the blocking ring surface area for scoring. Check for snug fit on main shaft. If it does not fit properly or if teeth are damaged replace the gear.

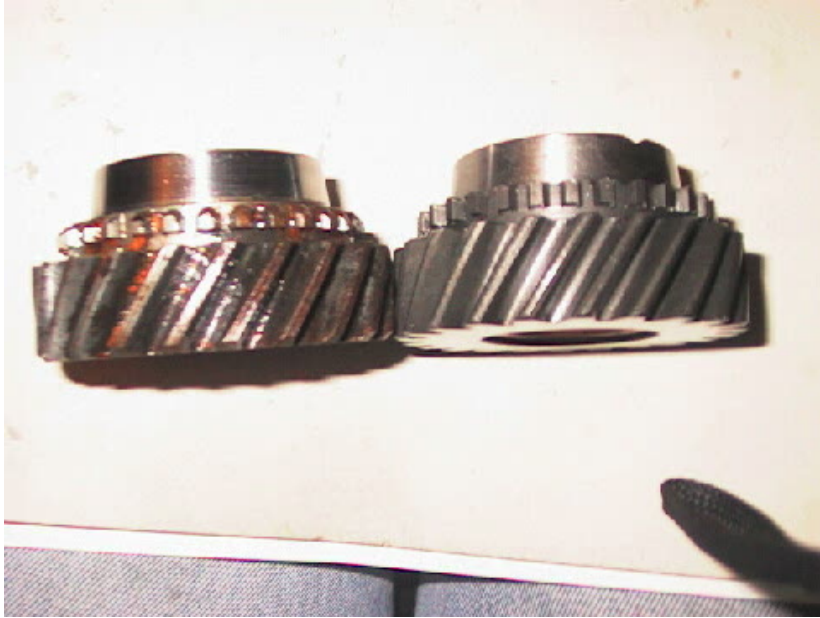
Frankie Ladwig provided us with this fine picture and some information from Jason at Mile High Jeep Rebuilders. Note the chevrons on the left gear as compared to the chevrons on the new right gear. These chevrons are what the clutch hub slide over to lock the tranny in second gear. If these chevrons wear down too far, they do not allow the clutch hub a proper gripping area and this can lead to the tranny popping out of second. Second gears are expensive but if yours is wearing down and been popping out of second I recommend you replace it. (The detent spring in the shift tower and the front and rear main bearings will also cause this problem.)

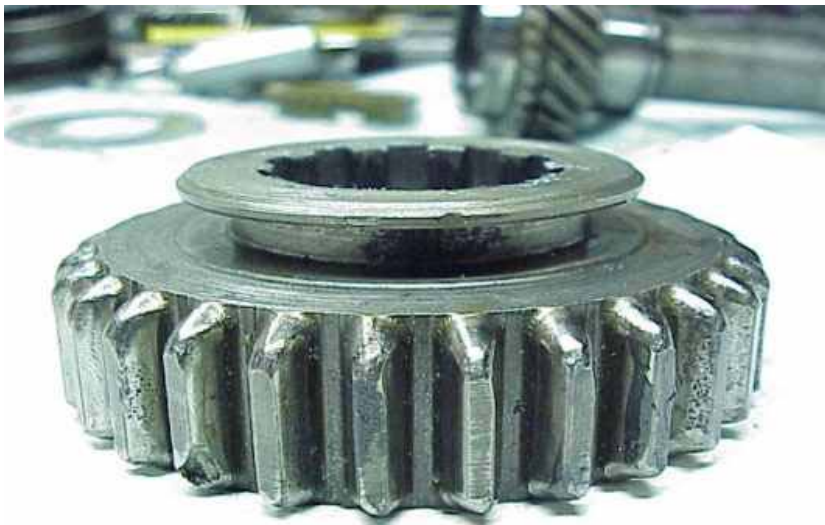
9. 1st/Reverse sliding gear

will take severe abuse due to its not having a 1st/Reverse synchronizer. Examine for broken or excessively worn teeth. Rounded and shaved teeth can still be used but gears with broken teeth should be replaced. Note the severely chipped tooth in the photo. Check for snug fit on mainshaft. If not replace the gear.

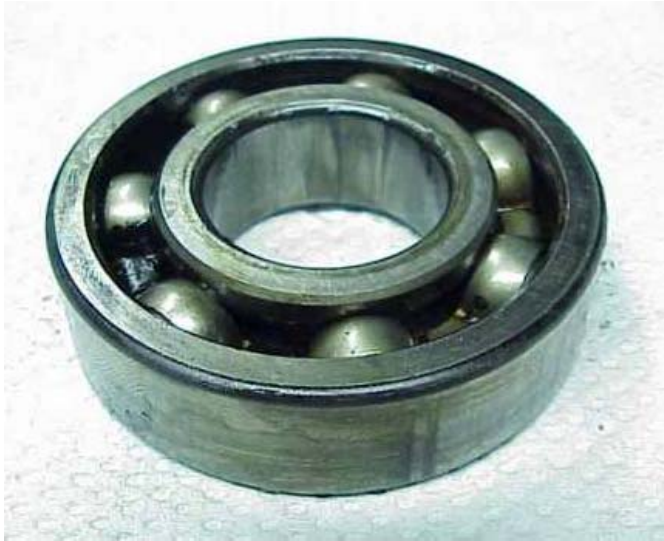
10. The Rear Main Bearing

should be replaced if the center hub fits loosely in the cage. Note that this bearing does not have a snap ring groove like the front bearing does. I also recommend changing this one regardless.

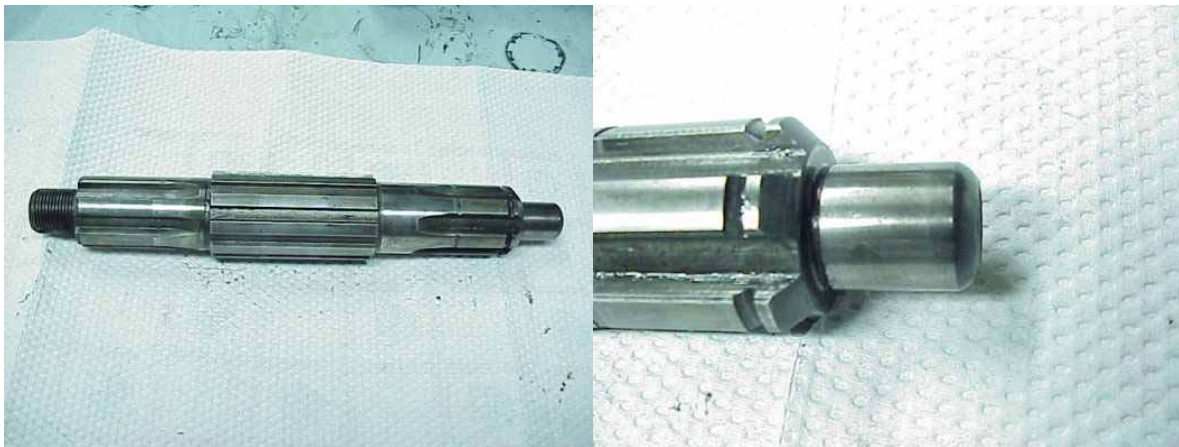
11. Inspect the Mainshaft

for cracks, chips and excess wear of the splines. Measure the mainshaft pilot shaft to determine if, with new roller bearings installed, it will be within .001" of the inside diameter of the Main Drive Gear. If not replace it. If this fit is loose it will cause excessive wear on the engine crankshaft pilot bushing.

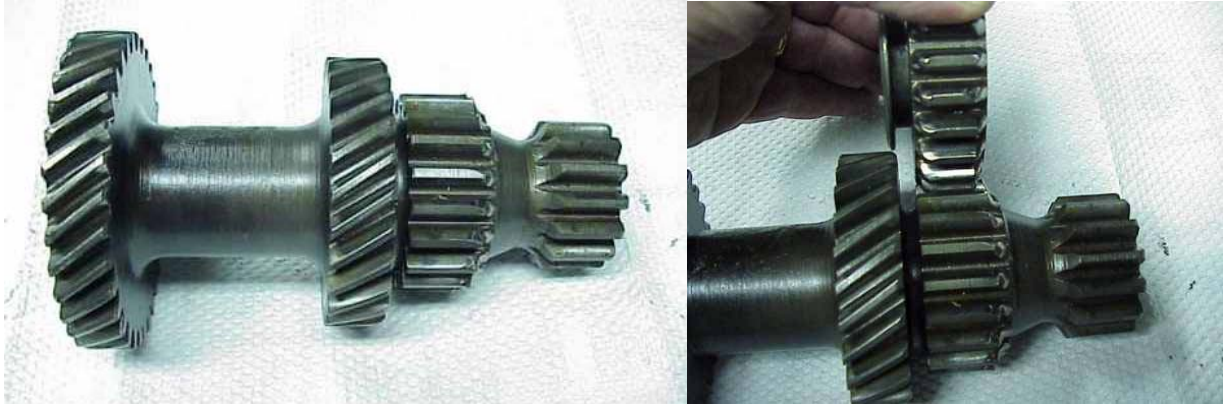
12. The Countershaft Gear Set (Known by most as the Cluster Gear)

should be examined for cracks and broken teeth. Because the 1st/Reverse gear rides well up onto the 1st gear ring on the Countershaft Cluster Gear, you can have as much as 3/8" of wear to the 1st gear ring without affecting the gear's operation. Small chips and sharp edges should be dressed with a file. With new Countershaft Washers, and bearings installed, the cluster gear should have no wobble on the countershaft. The easiest way to detect inside wear on the cluster gear is to run your finger inside and feel the surface. If you can feel ridges inside the gear, it is worn and should be replaced.

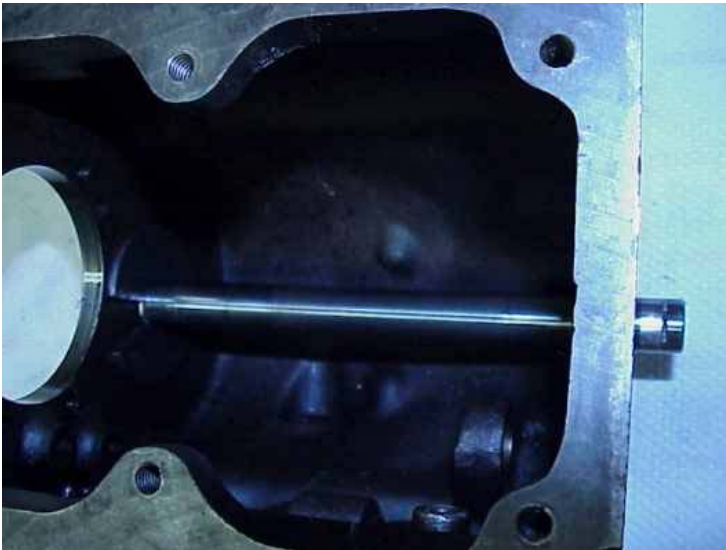
13. The Countershaft

should fit very tightly into the case. It should also have no perceptible grooves or ridges worn into the bearing surface. These shafts are cheap so do yourself a favor and replace it.

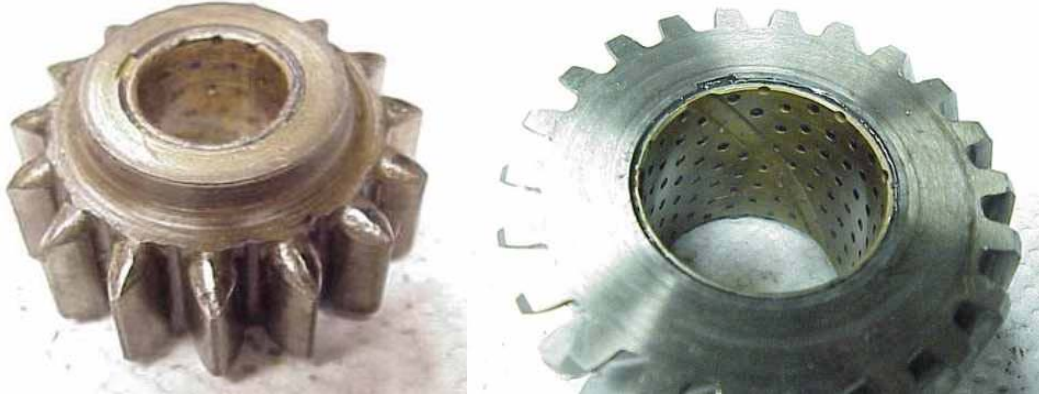
14. The Reverse Idler Gear

will have worn teeth. These should be dressed with a file to eliminate small chips or sharp edges that could be broken off and left inside the transmission. Check the fit on the Idler Shaft for wobble. The gear has a bronze bushing that should look like this. If it doesn't fit well or is missing large sections of teeth it should be replaced.

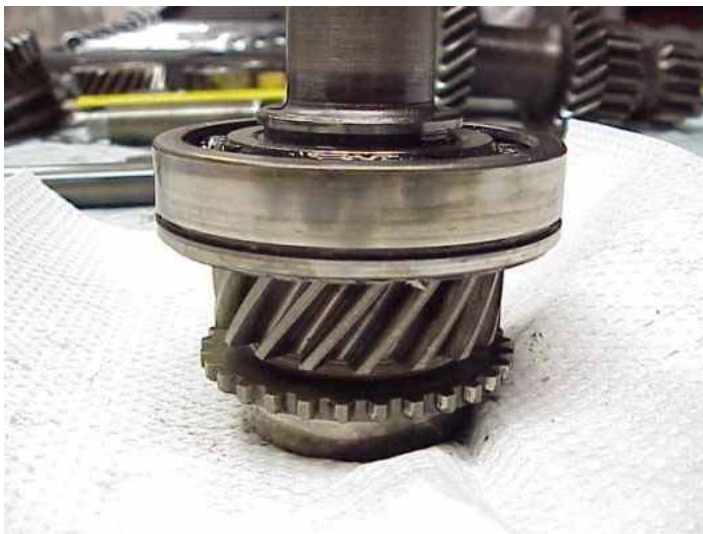
Make sure the snap ring groove is forward or you will have to do it again.

This bearing had to be removed and installed the right way. If you think I did it just for the photo, you don't know me very well. :-)

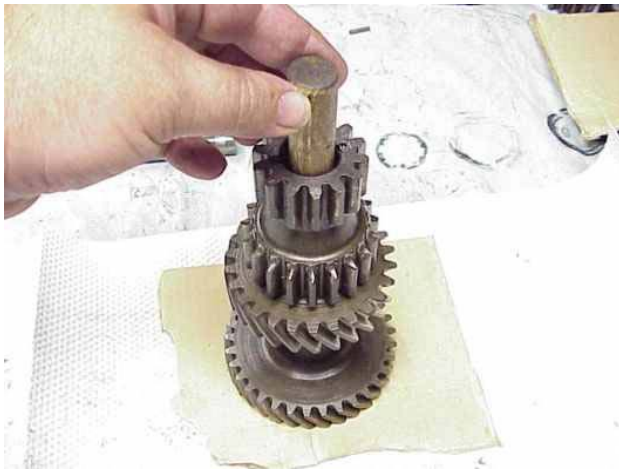
4e1. Stand the cluster gear on its large end on top of piece of cardboard and insert Tool A into the hole.

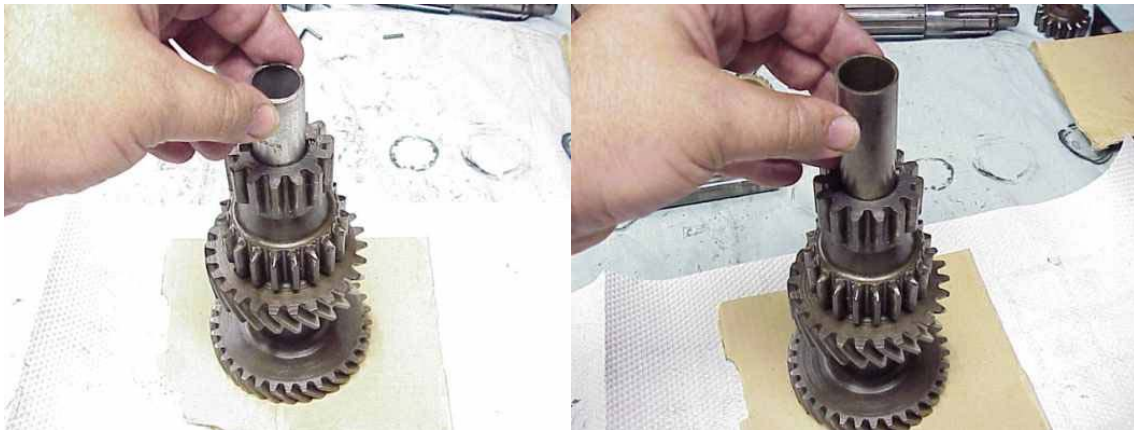
4e2. Install Tool B

and Countershaft Spacer over Tool A in that order.

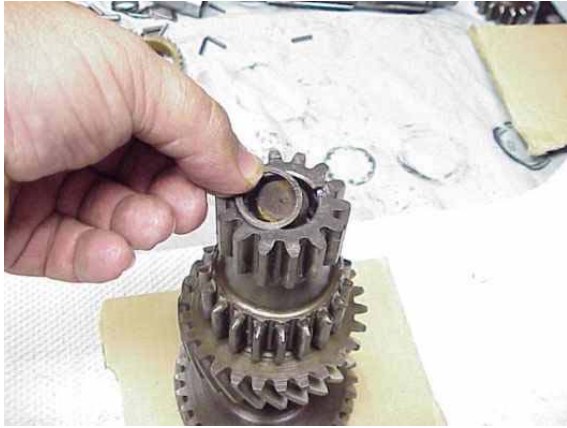
4e3. Install one bearing washer over Tool A.

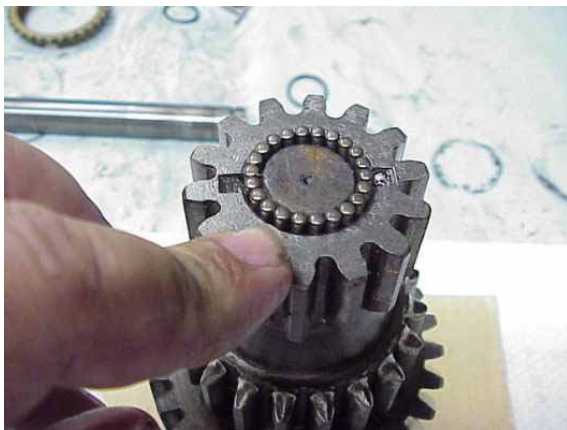
4e4. Install 22 needle bearings into the space left between Tool A and the Cluster Gear shaft.

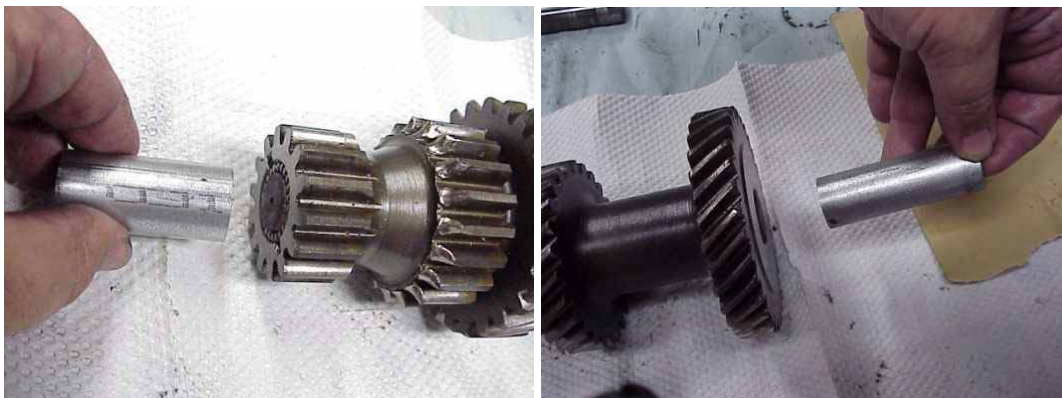
4e6. While holding Tool A in place, push the needle bearings into the shaft using Tool C and remove Tool B.

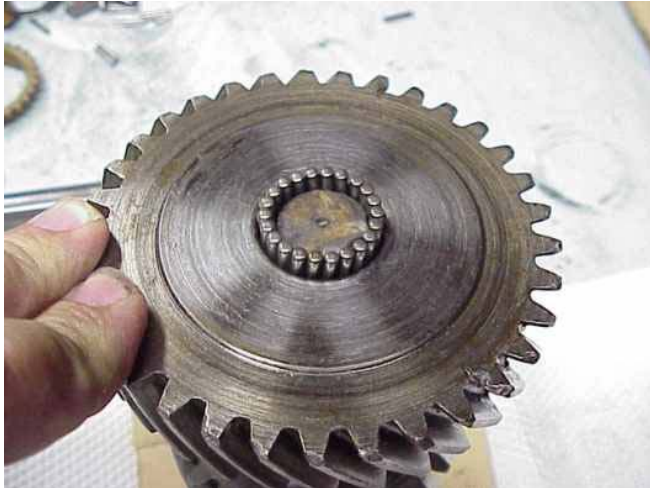
4e8. Install the 2nd bearing washer and 22 needle bearings.

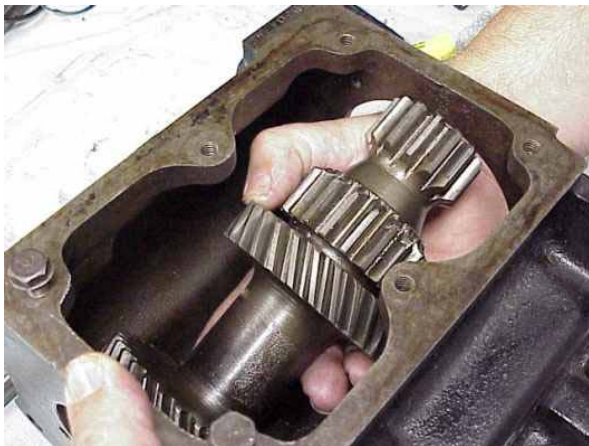
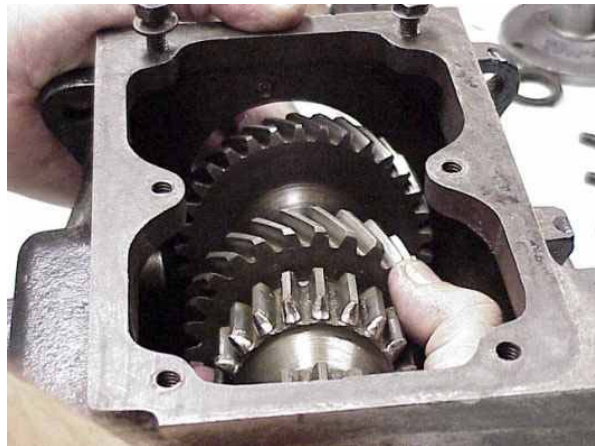
- 4i. Place the Countershaft Cluster Gear into the case with the large end to the front. It will just lay in the bottom for now.

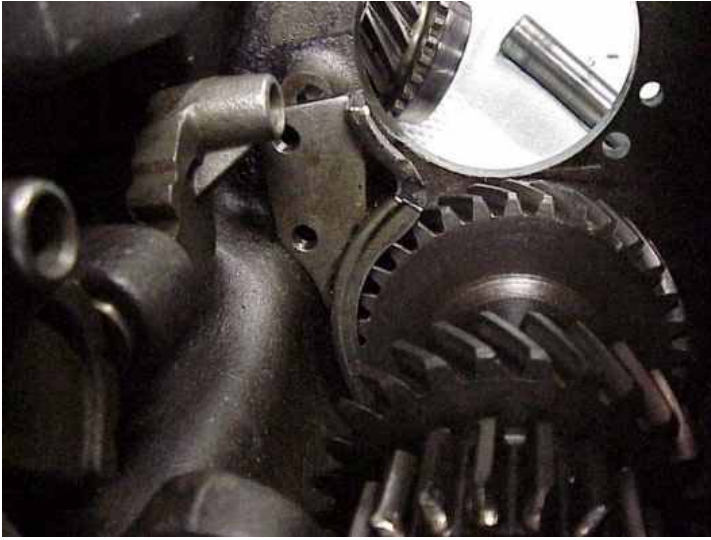
4j. Place the Oil Collector in position in the case.

Do not install the screws at this time. You will note on the left side of the photo some extra parts that your T-90 doesn't have. This is the shift mechanism for the side shift tranny. You can build a side shift T-90 to be a top shifted T-90.

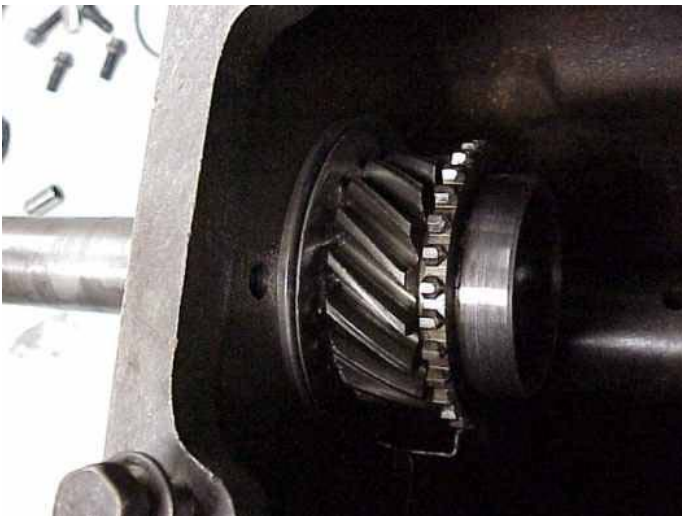
4k. Install the Main Drive Gear into case from the front. The bearing snap ring will rest against the front of the case.

Dr. Vern - I found it easier to install the pilot bearing rollers before installing the main drive gear. I have a magnet on a stick that worked great for handling those teeny little rollers, too. Things got pretty slick using assembly lube.

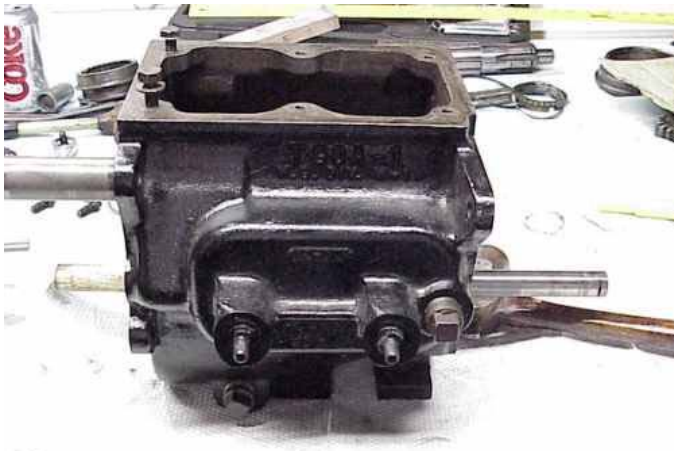
4l. Install the countershaft through the cluster gear from the rear of the case.

It may be necessary to stand the case on its end to get the thrust washers to align with the countershaft. Take your time and don't use too much force to insert the countershaft. If it isn't going in, then washers aren't aligned properly. It's ok to gently tap the end of the shaft with a brass hammer but any more force than that is too much. As the countershaft slides in, Tool A will slide out. Let Tool A fall out on its own if possible. This will help keep the thrust washers aligned. Make sure the locking plate slot that is cut into the shaft is at a 90-degree angle to the case hole for the Reverse Idler Gear Shaft.

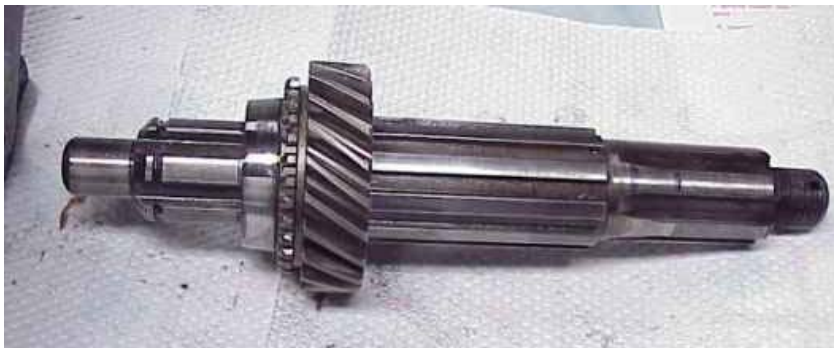
4o. Install the second speed gear onto the mainshaft with the blocking ring mating surface pointing forward.

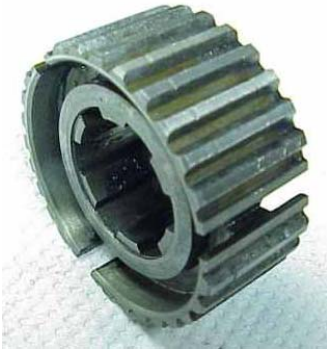
This photo shows the rear of the clutch hub with the shorter but wider boss. Some folks have confused the direction of this hub during installation and this prevented the transmission from going together. (Clarification for this step provided by Doug Karr)

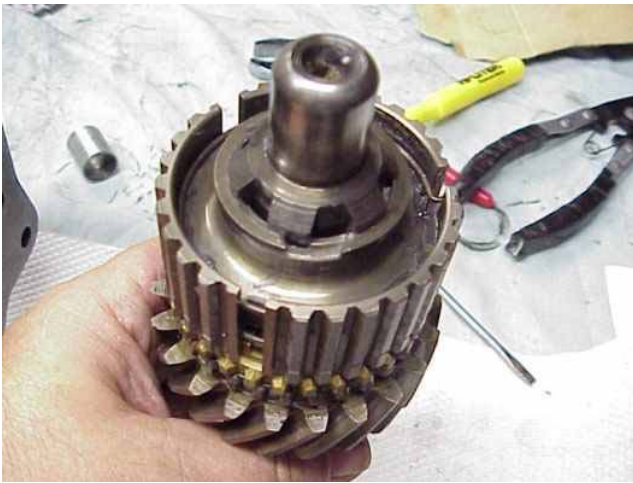
4s. Install the clutch hub snap ring.

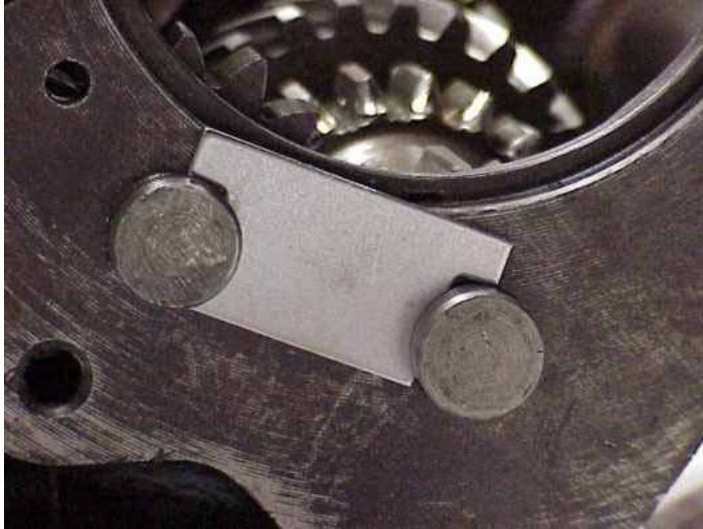
Gary- Major lesson learned last night. There's already some added comments in your text regarding the locking plate that secures the reverse idler shift shaft and the cluster gear shaft. On IH Scout using the T90/T18 combo, the locking plate MUST be installed from the top,

so that it is a right-side up "T". I put mine in from the bottom, put gasket shellac on all the gaskets and cranked everything down tight. When I filled both with the requisite 6 pints of gear oil and started the engine, I had a puddle on the floor pretty quickly. Tried quick fixes like shellac on the threads of the bolts that join the T18 and T90, but still had good flow. Took the two units apart last night and found that the locking plate is interference with the fit. Kinda like slipping a dime between the mounting surfaces.

Dr. Vern- During assembly, the shaft locking plate on the rear must be correctly positioned to fit into a recess on the front of the T-case. Rick's guide mentions this, and how one guy had the plate keep the T90 and T-case from pulling together correctly. I used the gasket as a template and traced the outline of the recess with a magic marker. When the two shafts were still protruding about an inch, that is when I fit the locking plate into the shafts' grooves. That allowed me to keep everything in correct alignment as I drove the shafts all the way in.
